Field Trip Guide Book - B08

32nd INTERNATIONAL GEOLOGICAL CONGRESS

LARGE SCALE GRAVITATIONAL PHENOMENA IN SOUTHERN-CENTRAL ITALY: GEOMORPHOLOGICAL FRAMEWORK, TRIGGERING FACTORS, TEMPORAL EVOLUTION, AND IMPACT ON HUMAN SETTLEMENTS

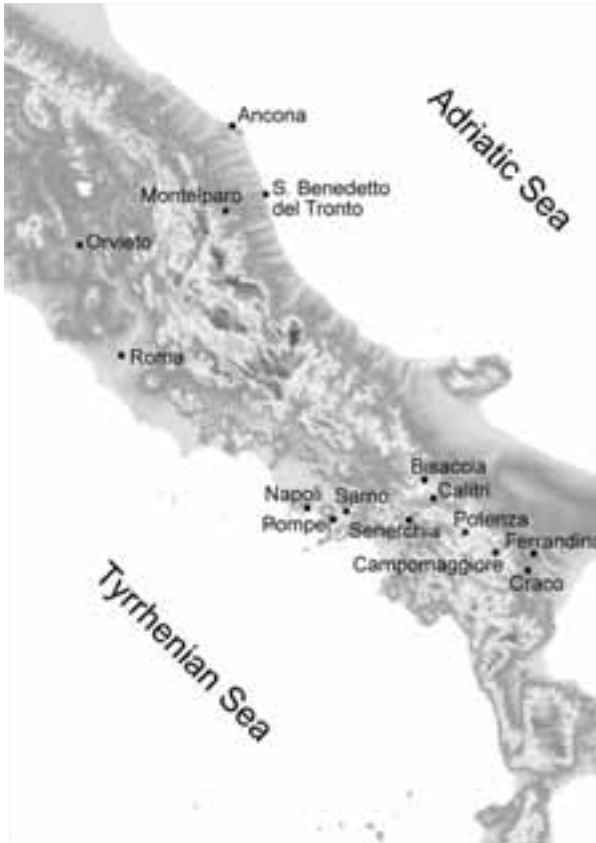
Figure 1.4 - The landslide affected towns which will be visited in the field trip.

The field trip will include five excursion days (August 15-19), from Valmontone (30 km south of Rome) to Florence (Figure. 1.4). During this period, a number of huge landslides affecting urban settlements will be visited. The first trip day will examine the towns of Bisaccia, Calitri, and Senerchia (in Irpinia, Campania Region), deeply involved in gravitational movements triggered by the November 1980 Southern Italy earthquake. The second day topics will be those related to the unstable towns of Craco, Campomaggiore, and Ferrandina, in the Bradanica Trough (Basilicata Region). The third day will start with a visit to the archeological roman settlement of Pompei, buried by the Vesuvius eruption of 79 A.D., followed by a scientific stop in the area of Sarno, struck by catastrophic mudflows in May, 1998. On the fourth day, two huge landslides mobilitating the urban settlements of the Marche Region (Ancona, on the Adriatic coast, and Montelparo, in the peri-Adriatic Plio-Pleistocene hilly belt) will be examined.

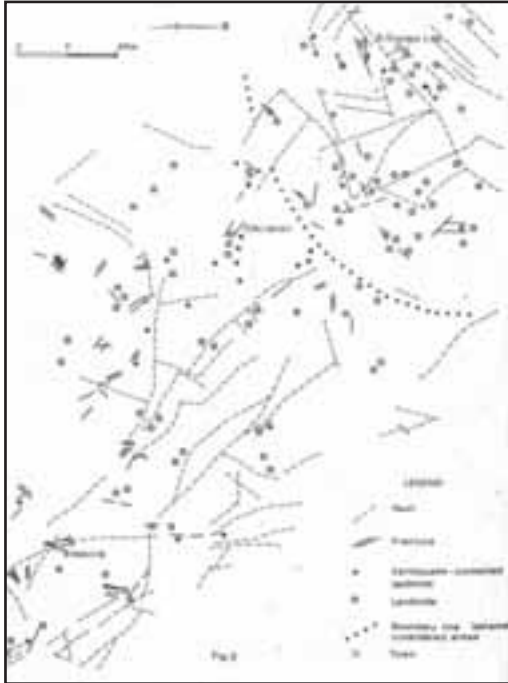
Figure 2.1 - Earthquake-induced ground fracture in the Ariano Irpino area (after Dramis et al., 1982, modified)

Widespread were surface fractures, both isolated or joined in groups (Figures 2.1–2.2), up to several kilometers long. They opened in a variety of lithologies (including loose superficial material, such as alluvial deposits and inactive landslide bodies) as a consequence of interference between seismic, tectonic and gravitational stress (Carmignani et al., 1981; Dramis et al., 1982)

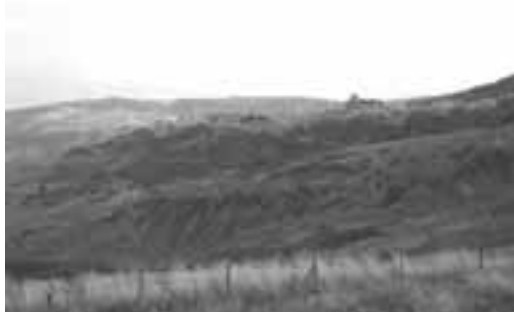
Figure 2.3 - The town of Bisaccia.

An important mass movement triggered by the 1980 southern Italy earthquake was the deep-seated sliding (Crescenti *et al.*, 1984) that involved most of the town of Bisaccia (Figure 2.3), located quite far away from the epicenter (the earthquake here reached only a VII MCS intensity). This town is built up over a terrace-like platform made up of a 50 m thick polygenic conglomerate (Pliocene), overlying strongly disturbed allocthonous clays (Varicoloured Clays - Argille Varicolori) of Late Miocene age.

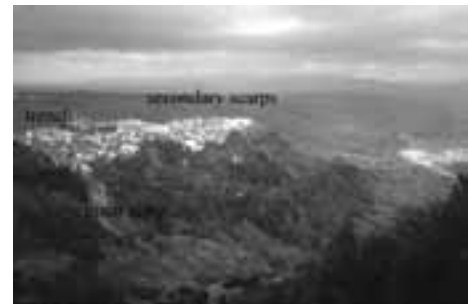
Figure 2.4 - The high escarpment which divides the old town from the modern one (out of picture, on the left side). Minor escarpments are visible within the built-up area. All of them can be interpreted as landslide scarps.

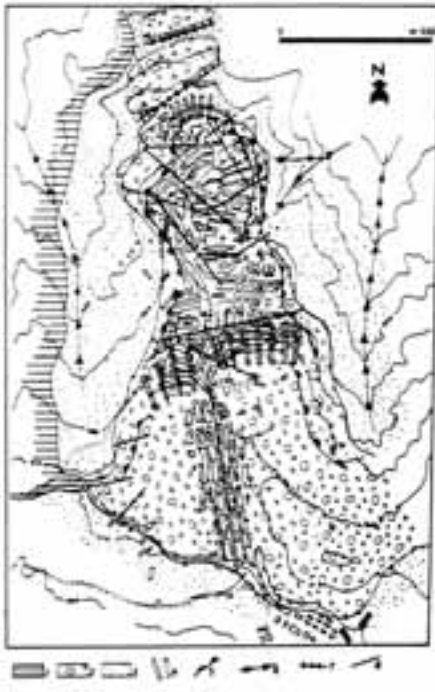
Figure 2.5 - Schematic geomorphological map of the Bisaccia area.
Legend: 1. “varicoloured clays”; 2. conglomerates; 3. debris; 4. main landslide escarpment; 5. edge of the conglomerate platform scarp retreating by mass movements; 6. stream erosion; 7. trench; 8. minor landslide scarps and fractures reactivated by the November 1980 earthquake (after Crescenti et al., 1984, modified).

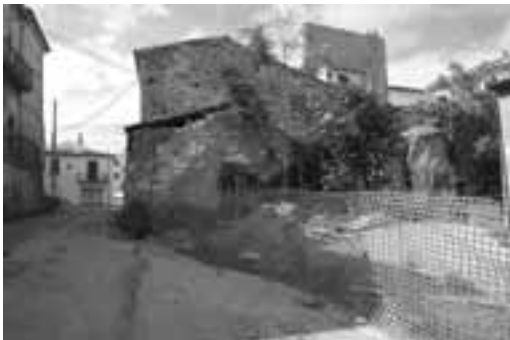
Figure 2.6 - Damage along a reactivated scarplet.

effects occurred in connection with the earthquake reactivated ground fractures and scarplets (Figure 2.6) and all along the edges of the conglomerate platform, where a number of buildings collapsed, as a consequence of local falls and slumps.

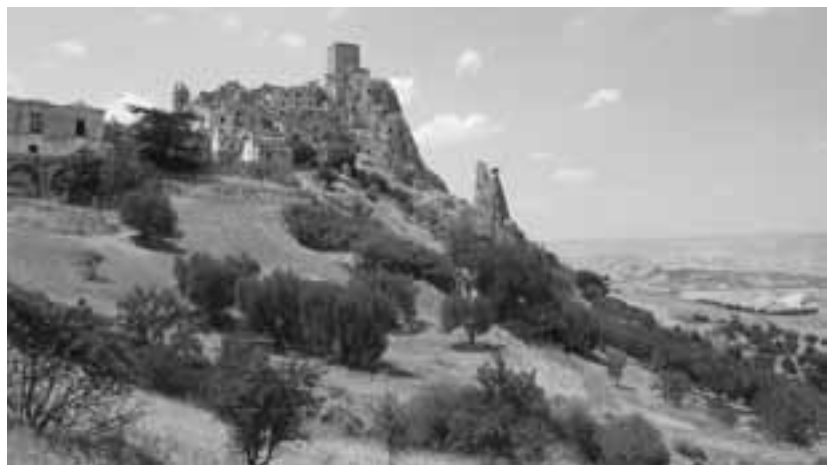
Figure 3.2 - The village of Craco.

The village of Craco (Figure 3.2) is located at 390 m a.s.l. on an undulating hilly ridge running northwest-southeast, which divide the valleys of the Bruscata and Salandrella rivers.

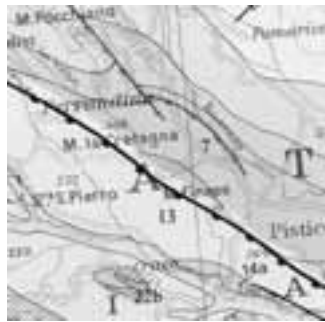
Figure 3.4 - Geological section along the Craco landslides.

destroying the oldest parts of the village of Craco. It shows the characteristic features of a retrogressive landslip, with a very long mudslide originating from its toe (Figure 3.4). The complete length of

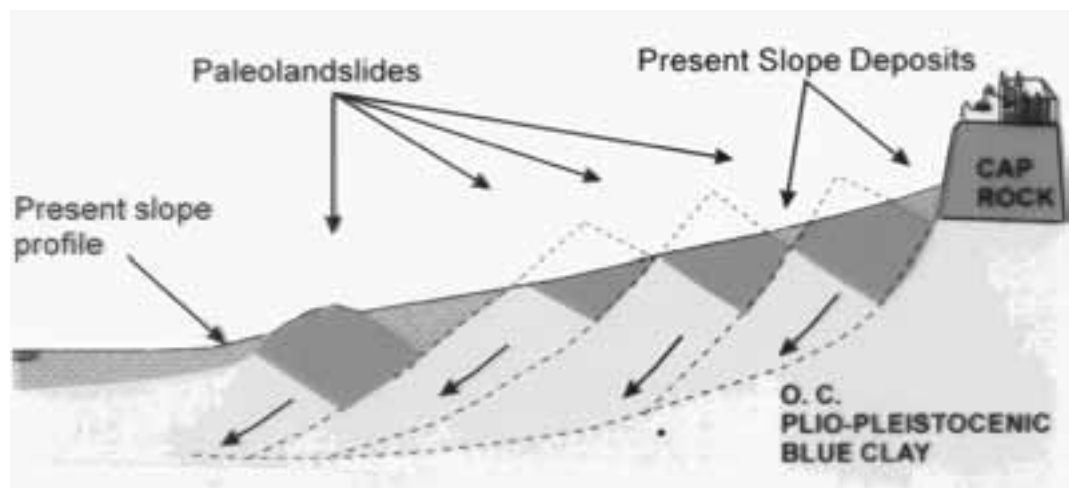
Figure 3.6 - Section along the Castelluccio slope, showing the occurrence of ancient landslides remobilized by the landslide.

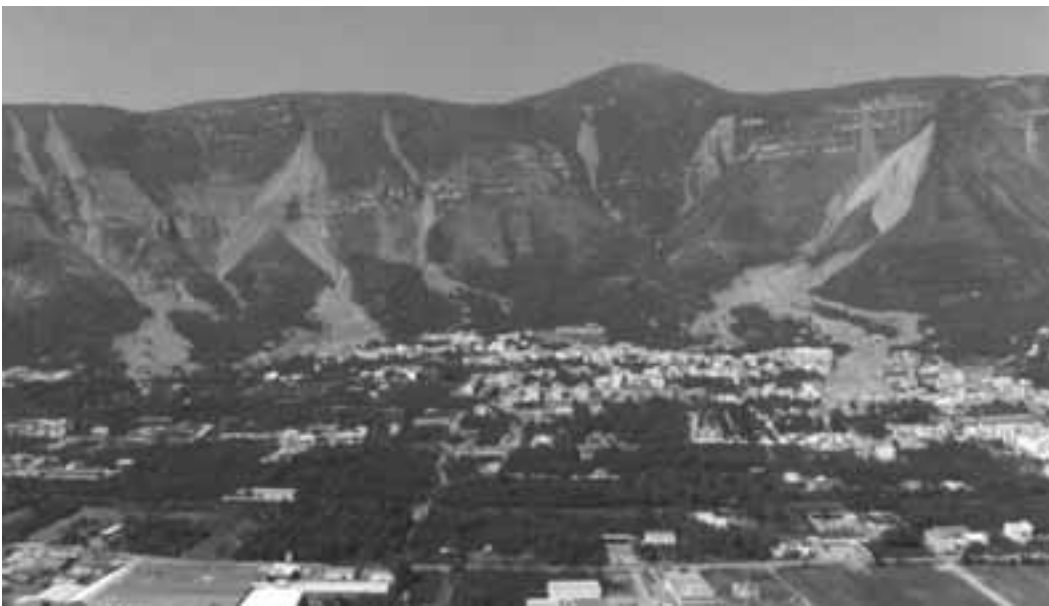
Figure 4.5 - Photo of debris avalanche paths reaching the town limits of Sarno.

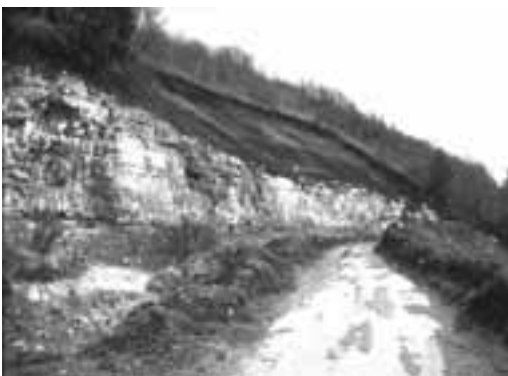
Figure 4.6 - Pyroclastic materials overlying the limestone slopes in the Sarno area.

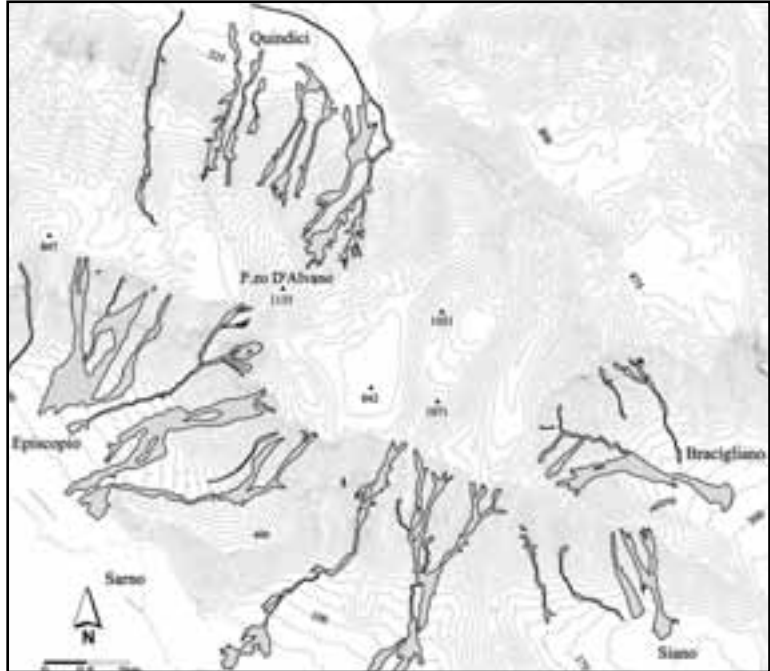
Figure 4.8 - Pattern of the 1998 flows along the Pizzo d'Alvano ridges

structure is fundamental to the development of landslide phenomena, as it controls the mechanical and hydrological behavior of the slopes. During the 1998 Sarno-Quindici event, several millions of m³ of slope materials were displaced in the landslides, and were classified as debris avalanches and debris flows, following Hungr *et al.* (2001) (Figure. 4.8).

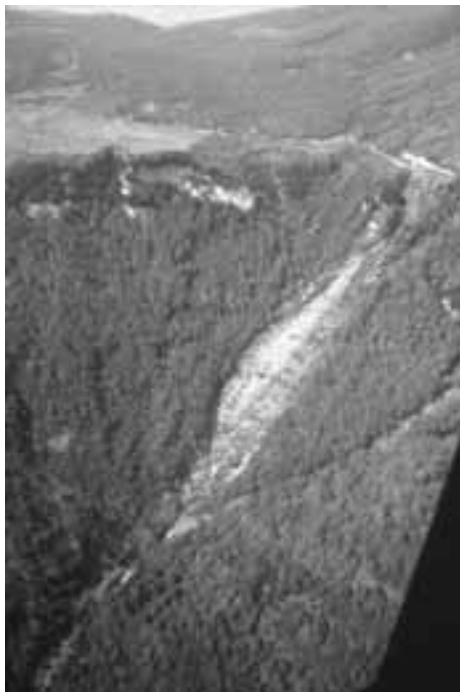
Figure 4.9 - A flow movement started from a road cut.

on surfaces inclined at 40°-50°, often at the heads of gullies. The locations of the instabilities appear to have been controlled by the presence of natural scarps and artificial trackways cutting the slopes (Figure. 4.9) (Guadagno, 2000).

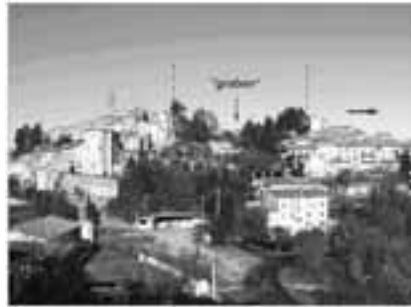
Figure 5.2 - Graben structure (the horizontal arrow indicates the moving part of the village)

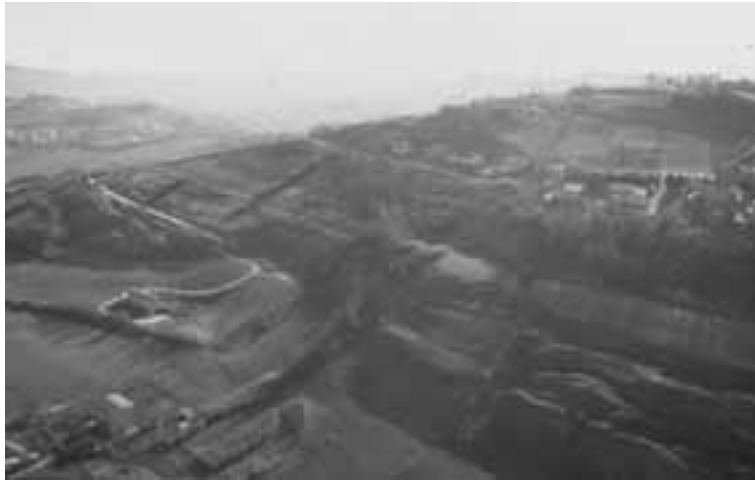
Figure 5.6 - Aerial view of the December 1982 Ancona landslide.

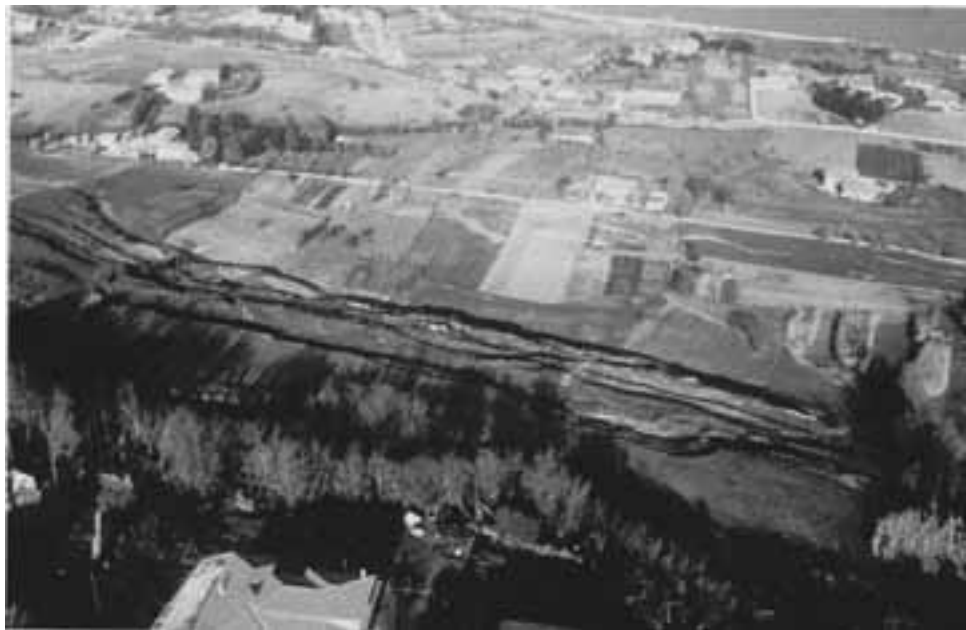
Figure 5.9 - Heavily-damaged buildings in the 1982 landslide affected area.

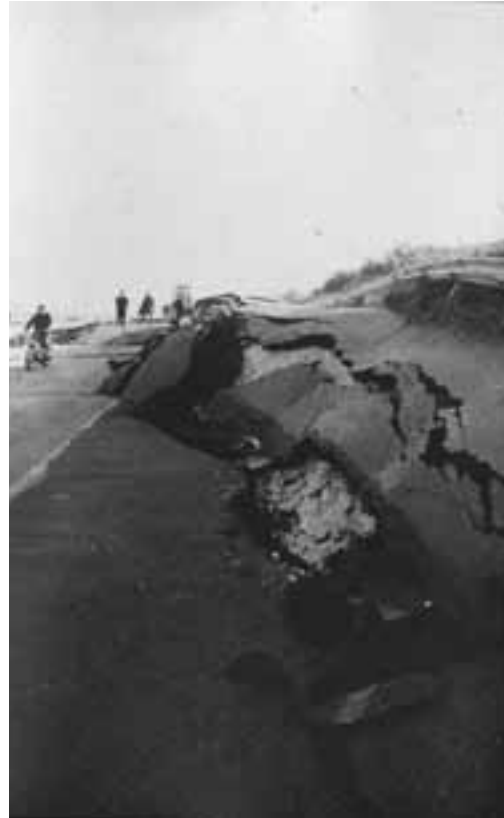
Figure 5.10 - Damage to the Adriatic railway at the landslide toe.

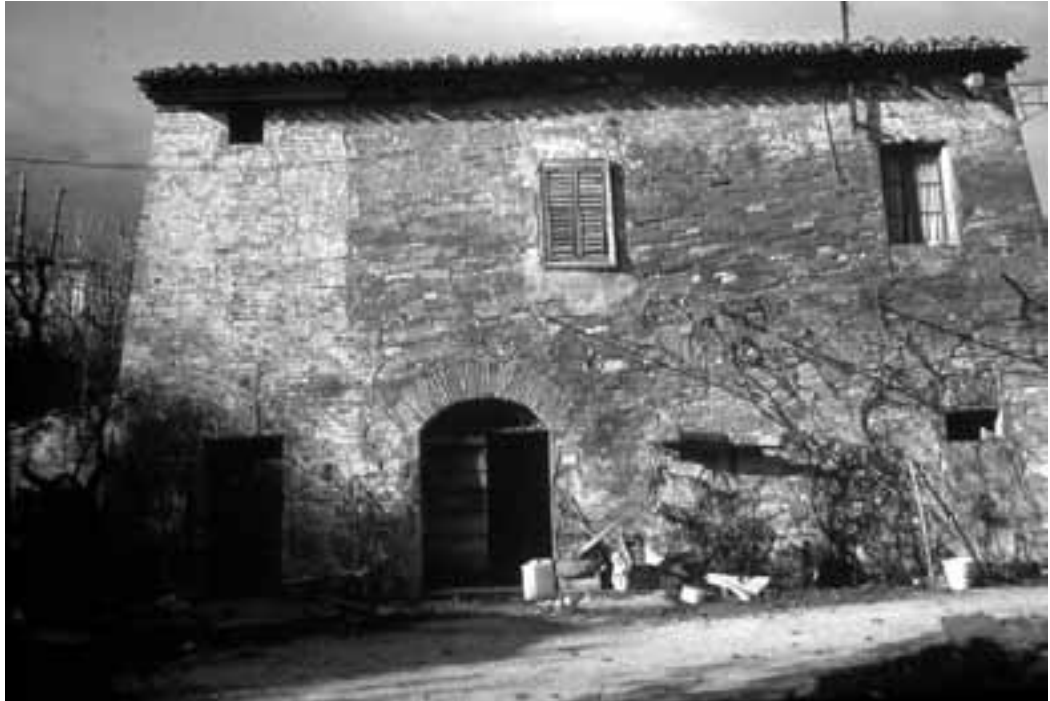
Figure 5.11 - A 16th century post-house, showing the cumulative effects of recurrent landslide movements on the Montagnolo slope.
