Field Trip Guide Book - PW06

**GEOLOGICAL AND
GEOTECHNICAL HAZARDS
OF MAJOR NATURAL
AND ARCHAEOLOGICAL
MONUMENTS**

PW06

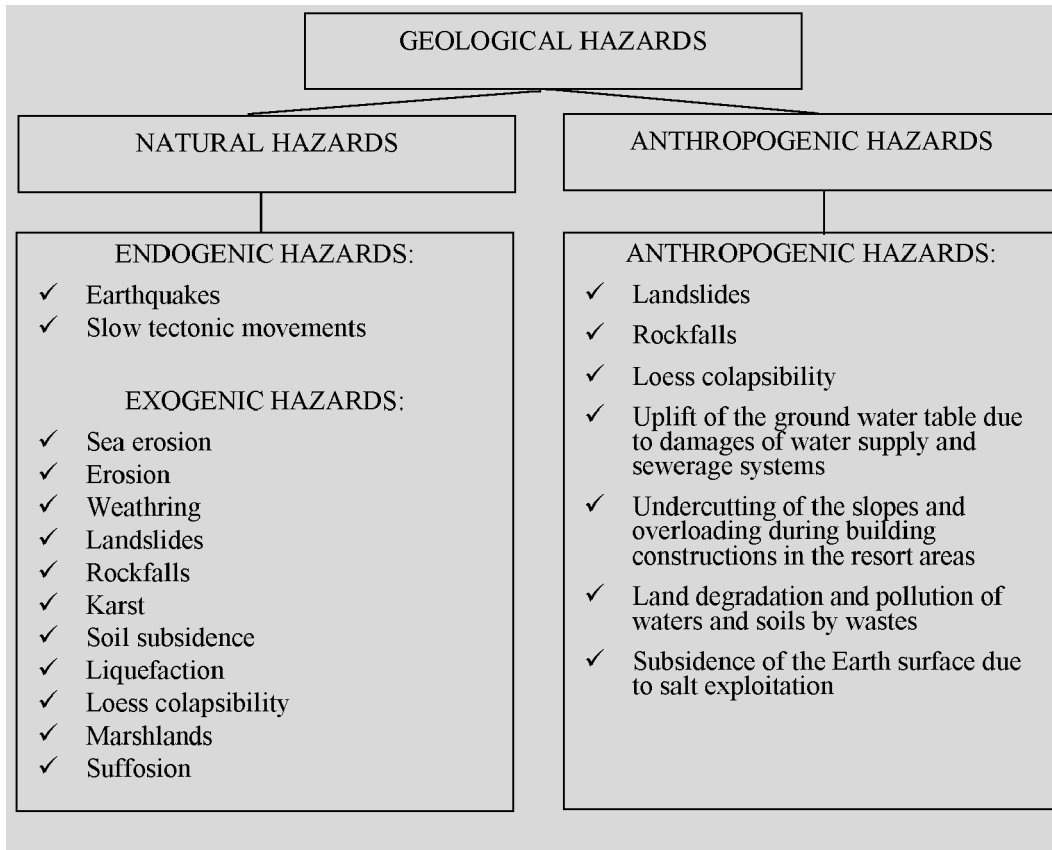
Figure 3 - Structure of the geological hazards in NE Bulgaria

The structure of the geological hazards involves many and variable destructive geological processes (Figure 3). Seismic intensities of the region are from 7 to 9 degrees MSK-64. The most important earthquake sources are located in the areas of Shabla-

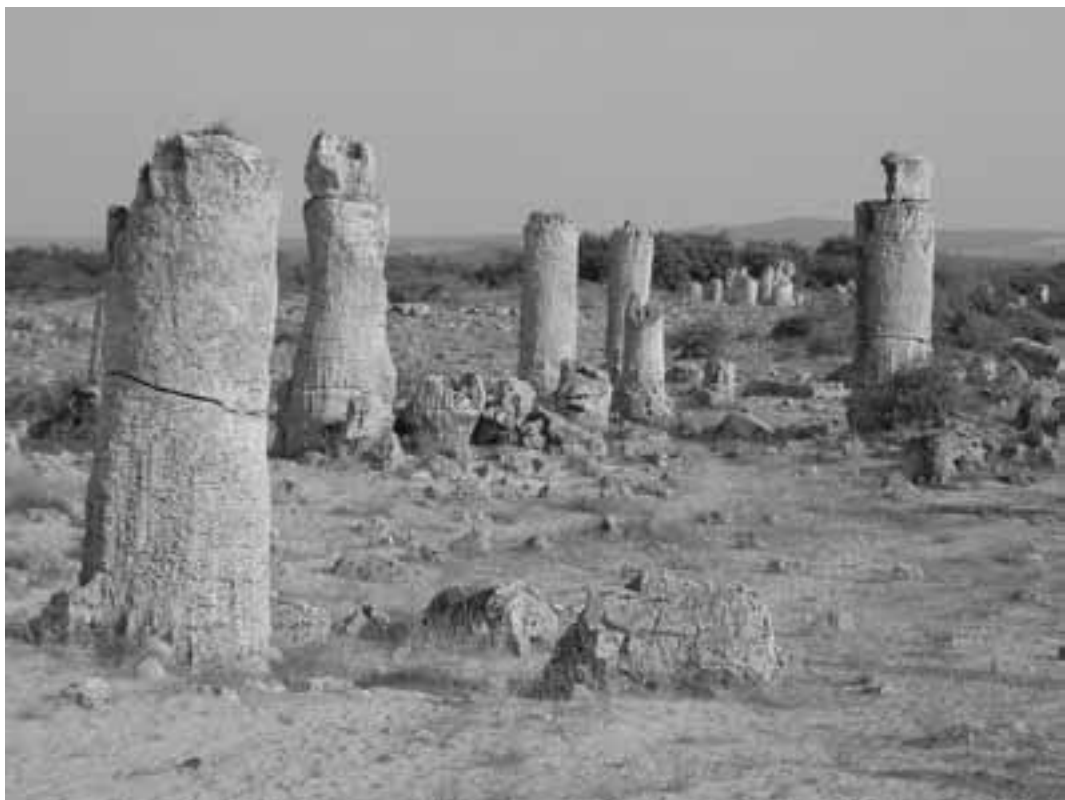
Figure 4 - View of the Upright stones

The "Pobitite kamani" site is located about 20 km West of Varna City, and it is a very interesting object of national and international tourism. (Figure 4) In Bulgarian, the name means "Upright stones".

The "Pobitite kamuni" site is apart from the so-called Varna columns. The columns can be divided into 5 groups, which are exposed over an area of 70 km². The host rocks are loose sands and silts. In some places, there are 5 levels of columns, which are separated by shallow-marine limestone layers. The whole geological section has a thickness of 40 - 45m.

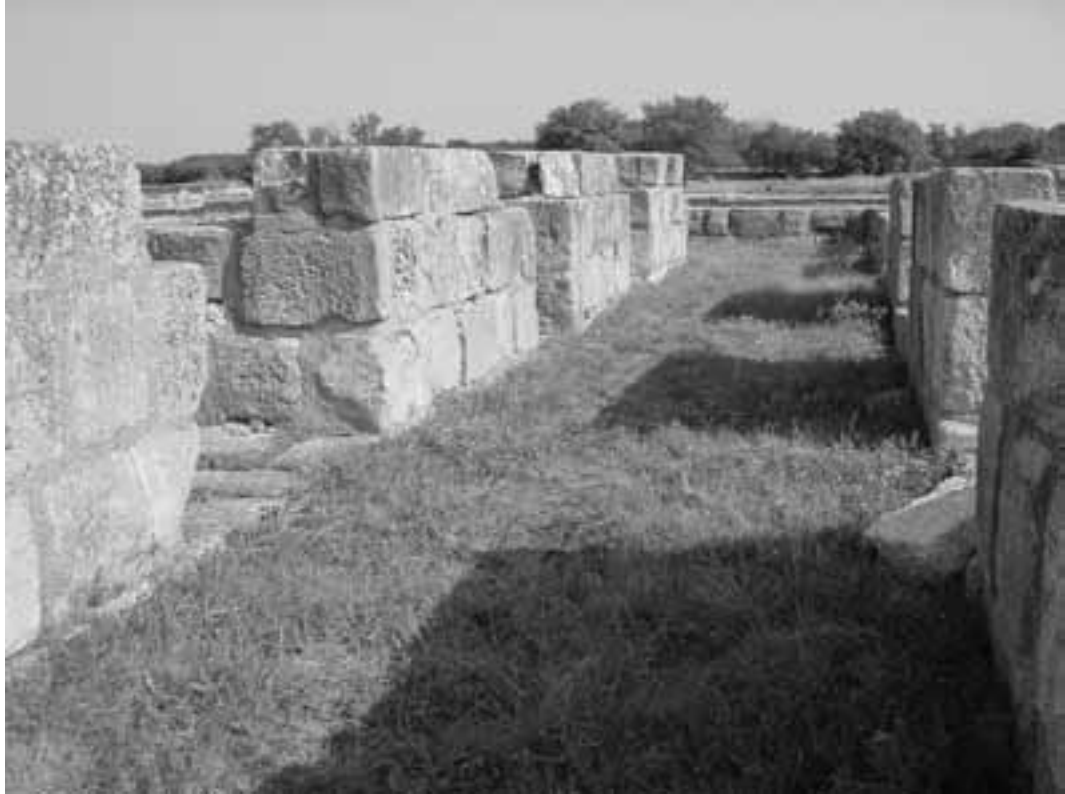
Figure 6 - The ruins of Pliska

(Figure 6). The city comprised of an inner and an outer part, and the area was about 23 km². A defense embankment surrounded the city. It was 21 km long, with a fortress wall 2.9 km long and 8-10 m high. Inside the city, a great number of houses, stone palaces, and churches were built. The Big Basilica was one of the most impressive religious structures built on the Balkan Peninsula at that time (Figure 7).

1. The building of a cushion of compacted soil 0.2-0.4 m deep, on top of which a layer of mortar was poured;
2. The building of a substrate that consisted of a wooden raft with mortar poured on top of it;
3. The compaction of the bottom of a ditch made for the foundation of wooden piles, stuck in the soil: 0.6-0.8 m long, with a diameter of 0.08-0.10 m;
4. The construction of a substrate, consisting of a wooden raft on piles, with mortar poured onto them.

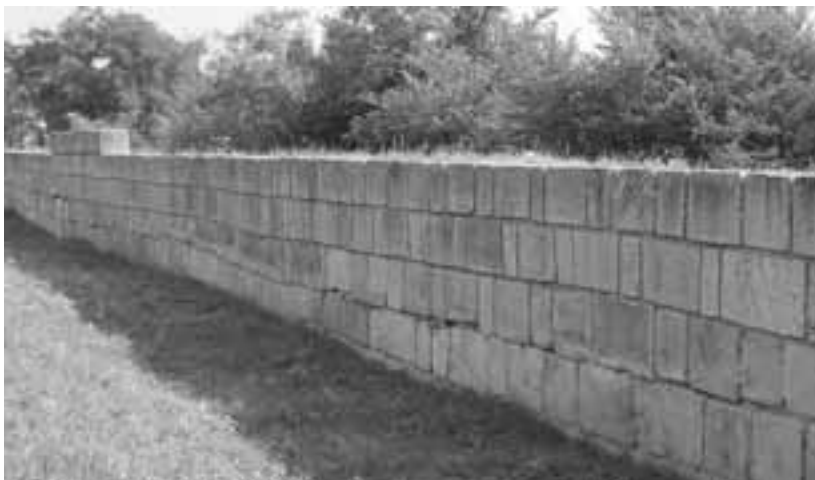
Figure 8 - Loess subsidence affected the Pliska walls

According to the older descriptions, a part of the ancient capital of Pliska was founded on marshland area. The main hazards are the high seismicity (8th degree MSK) and loess collapsibility (Figure 8).

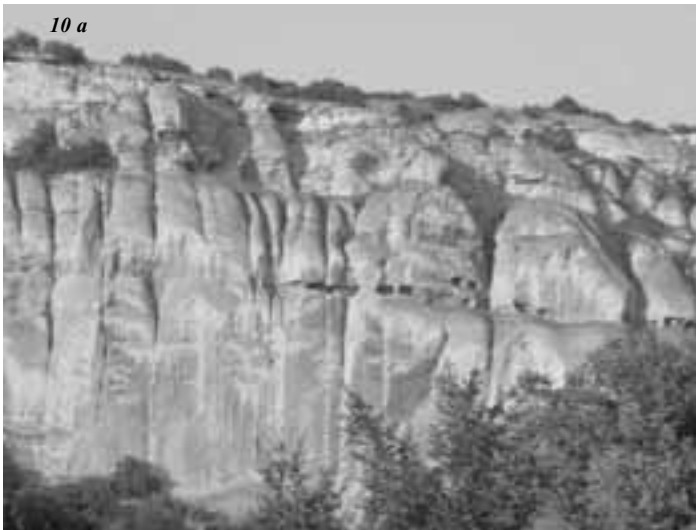
Figure 10 - a) General view of the Madara Plateau periphery; b) rock relief of the Madara Horseman on it.

to the east of the town of Shoumen, 70 km to the west of the town of Varna and 10 km to the SSW of the first Bulgarian capital - the town of Pliska. The historical bas-relief is situated in a place with many other historical monuments that are involved in the Madara archeological and historical reserve (Figure 10).

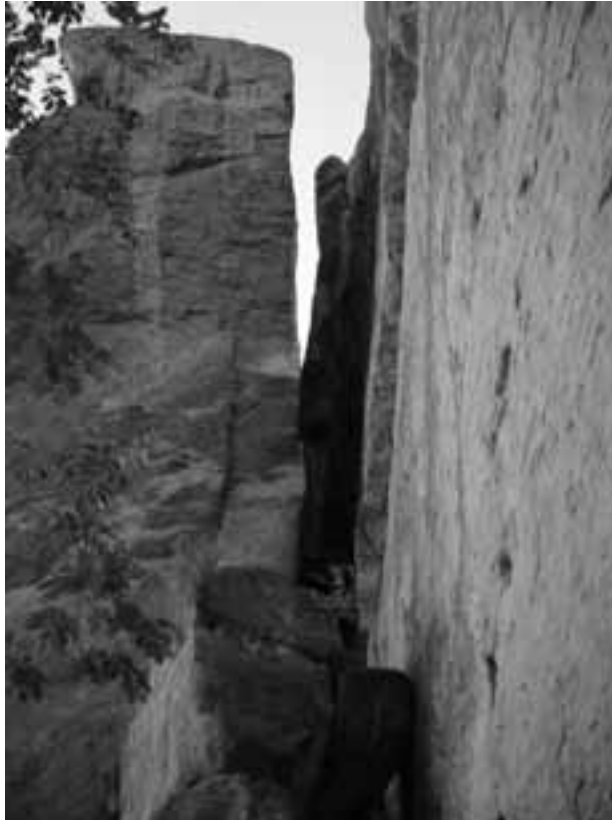
Figure 13 - Rock slices divided from the plateau

The peripheral zone of the Madara Plateau developed a specific structure of rock slices released from the edge (Figure 13). The slices or blocks show a thickness of from 1 to 3 m on average. The Madara Horseman cross section developed six slices like that, separated from the plateau. The first three of them can be found now as very low steps in the lowest section of the wall and are relics of old frontal blocks which disintegrated in

their towering heads. The bas-relief is carried by the fourth rock slice, which is followed by other ones. Formation of two or three new slices about 3 m wide can be detected behind the furthest edge of the plateau by traces of cracks.

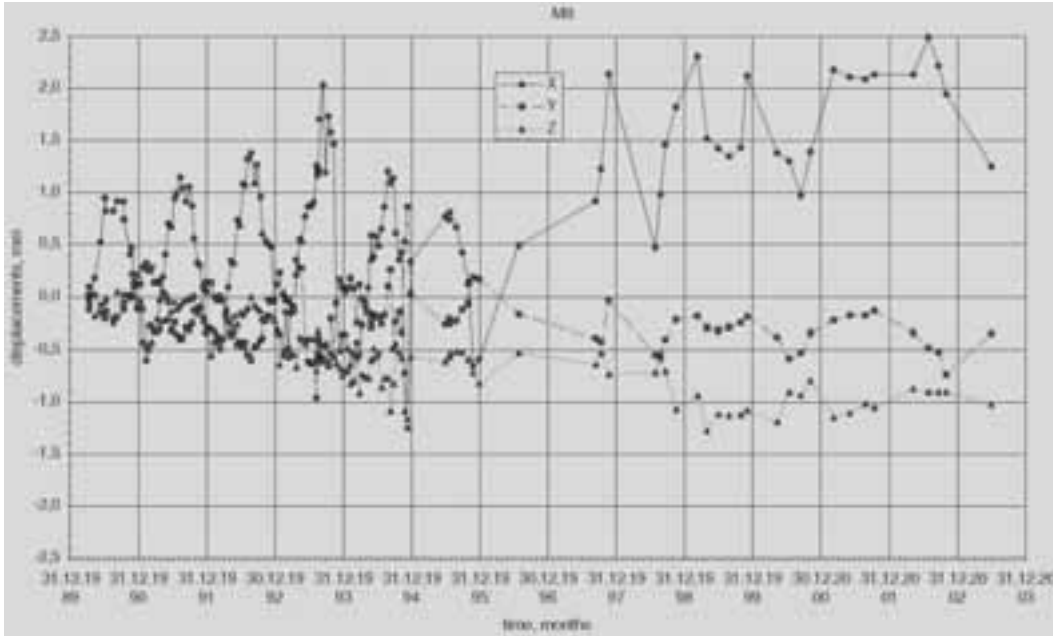
Figure 14 - Measured displacements along crack no.2

Crack gauges of the type TM-71, as applied to many rock stability projects, were successfully installed here in 1990 (Figure 14). According to the seismotectonic prognostication of NE Bulgaria, the Madara Plateau and its wider region is characteristic of high potential seismicity, whereby earthquakes with magnitudes more than 5 could be generated.

The data about displacements are given in three components X, Y, and Z, where X and Y are horizontal, and Z - vertical. Regarding the powerful gravitational forces, Z is to be seen in connection with subsidence, having mostly a shear character in the respective crack. The component Y represents mostly horizontal shear, whereas component X represents the opening or closing in all of the three investigated cracks. Angular deviations indexed XZ and XY represent turns round axes Y and Z, respectively.

To characterize the displacement diagrams, one can see at first certain delayed responses to seasonal temperatures. They reflect volumetric changes in the rock, mainly summer opening, and winter closing, of cracks, resulting in a seasonal character in X, sometimes produced in Y or Z, also. Temperature variations in the rock appear in a span of 45°C, from -7°C to +38°C, as recorded, resulting in up to 1.6 mm seasonal amplitude, as seen at M8 and M9.

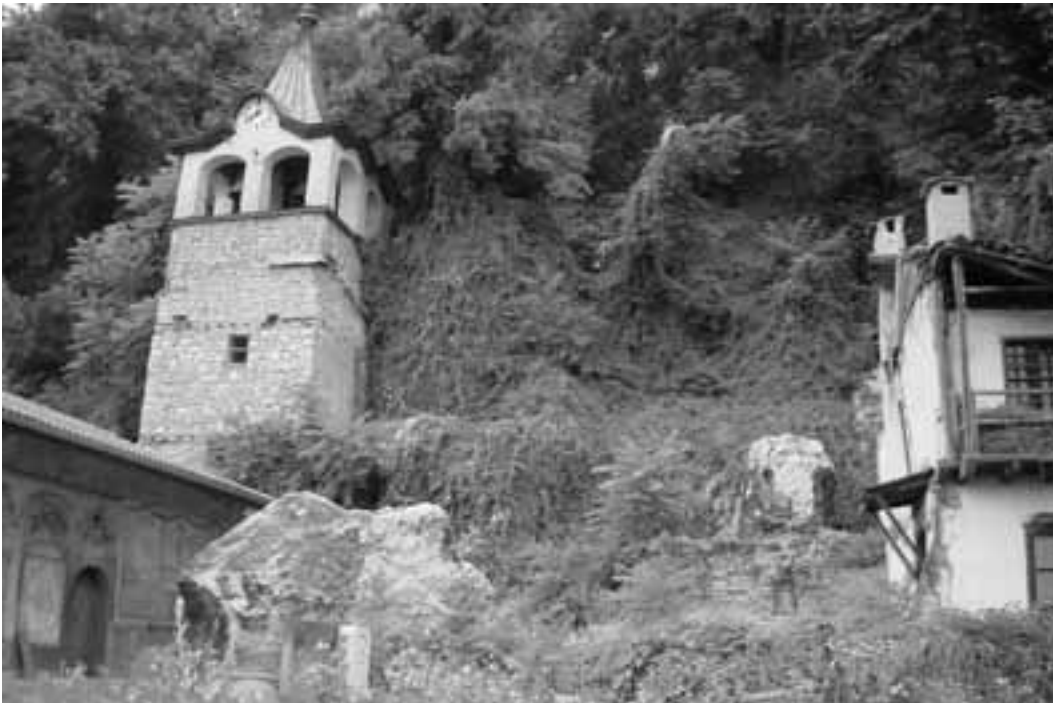
Figure 15 - View of the Monastery after the rock-fall

The Transfiguration Monastery (Figure 15), is located 7 km N from Veliko Turnovo – the capital city of the second Bulgarian State (1189-1393).

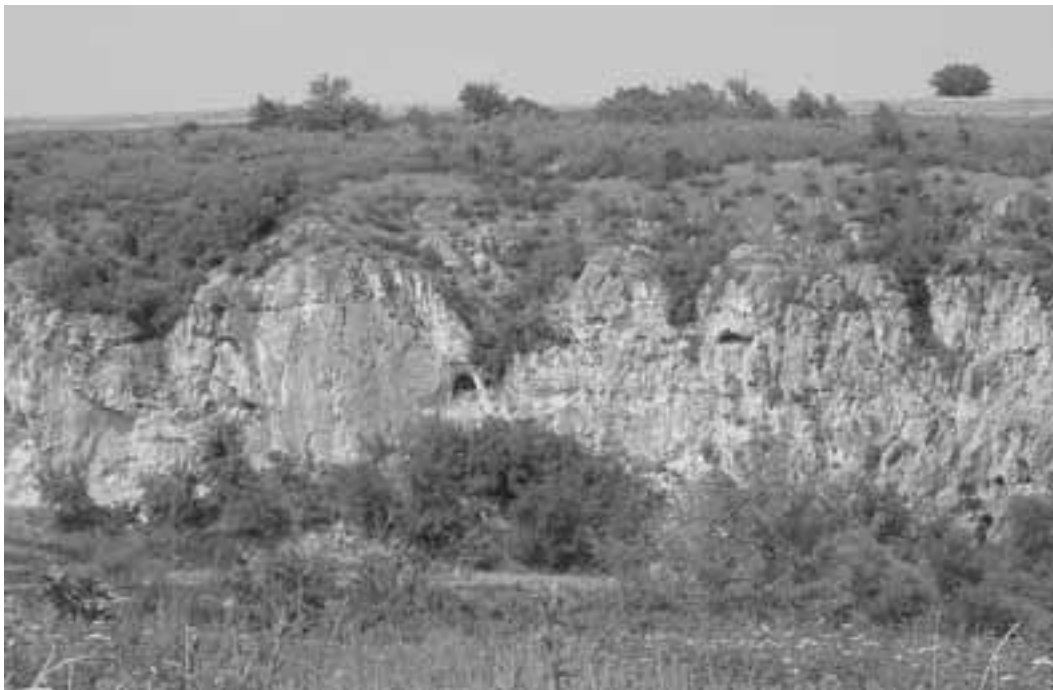
Figure 18 - The side of the canyon of the Rusenski Lom River

The Ivanovo rock churches are located 5 km outside Ivanovo Village, 25 km south of Rousse City, in the picturesque canyon of the Roussenski Lom River Reservation (Figure 18). In this place, the river forms a big meander with a wide valley. The high rock scarps are almost vertical, and their height often reaches 100 m. The altitude of the site is about 120 m a.s.l.

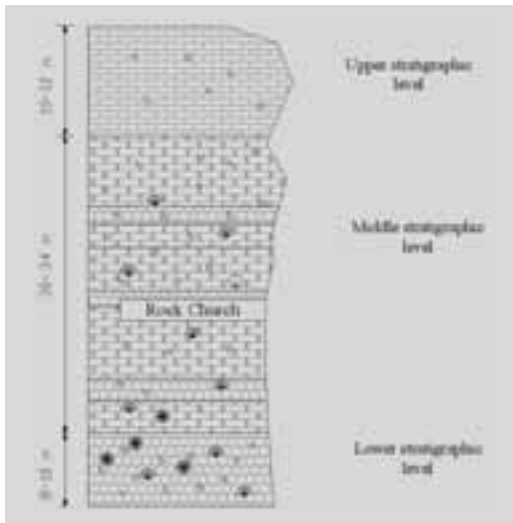
Figure 20 - Geological profile

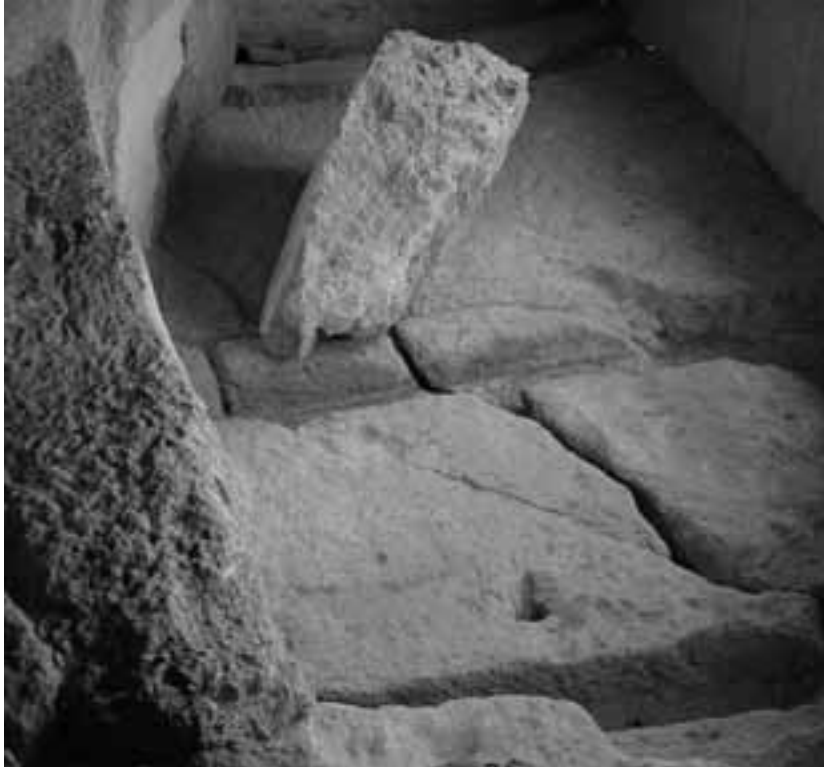
Figure 21 - Internal view of the Church, with the fractures and blocks outcrop.

Totally four sets of joints, and about 20 individual fractures, were established for the site and the church. Some joint groups are parallel to the bedding planes (Figs. 21, 22). Probably they were initially

Within the Church, the joints systems are presented by individual fractures that occur on the floor, the walls and the sealing surfaces, and create more than 10 separate blocks.

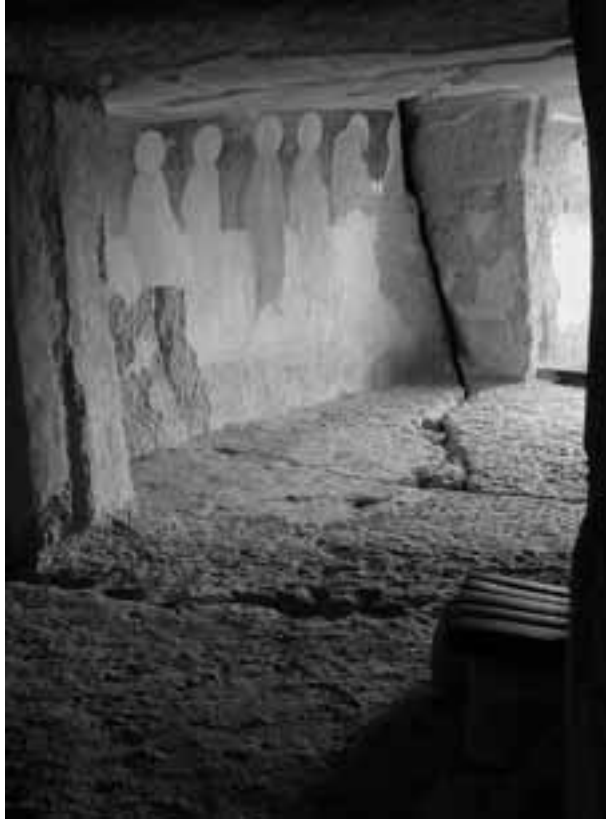
Figure 22 - Internal view of the Church with the fractures.

Some joints from the church rooms have apertures from 3-4 to 10-15 cm, with a rapid convergence of their walls up towards the cliff top. Only a frontal blocks system, engaging the outer part of the Church premises, outcrops today's surface and was estimated to be free to fall (slide) at the front (northern) wall of the cliff. It is the only one with a visible displacement of a gypsum mark by 1-2 cm up until 1983. All other blocks occurring inside the church seem to be interlocked and not vulnerable to falling. A similar pattern of destruction of the cliff is observed along

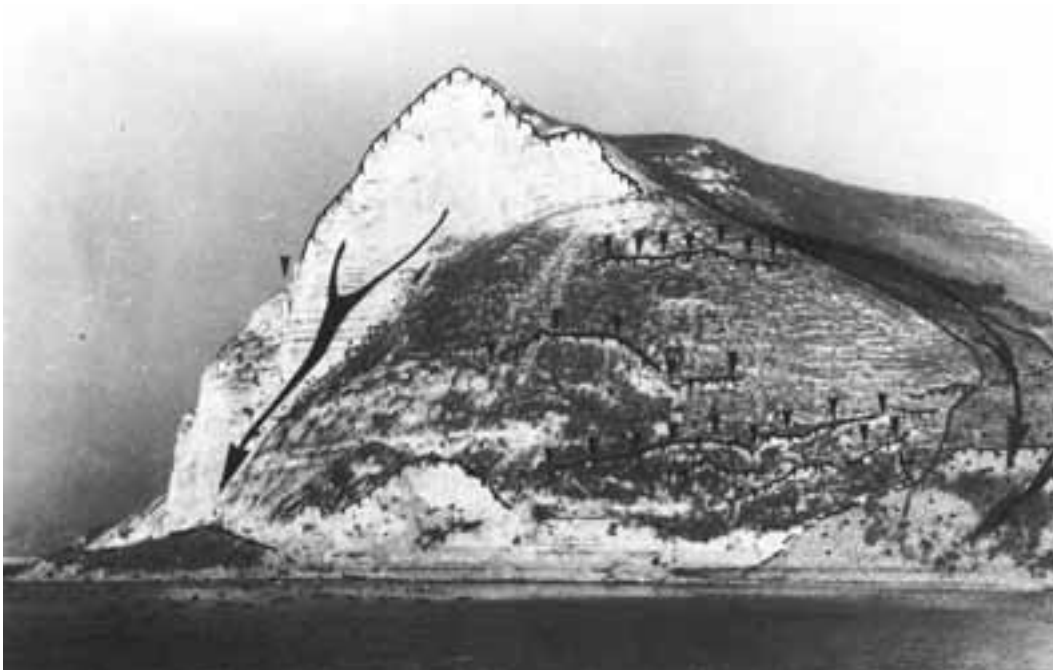
The relief is characterized by a large plateau which reaches the sea shore and large landslide strips below the peripheries of the plateau. The Dobroudja Plateau

Figure 28 - General view of Chirakman Cape (Evstatiev & Rizzo, 1984)

clearly denotes that the end of the city was caused by a fall-type landslide, that slid into the sea. On the basis of archaeological data collected in Bulgaria the abandonment of the ancient city dates back to the 1st century B.C.
