The management of cultural heritage in sites prone to natural hazard

La gestione dei Beni Culturali soggetti a fenomeni naturali

MARGOTTINI C. (*), SPIZZICHINO D. (*)

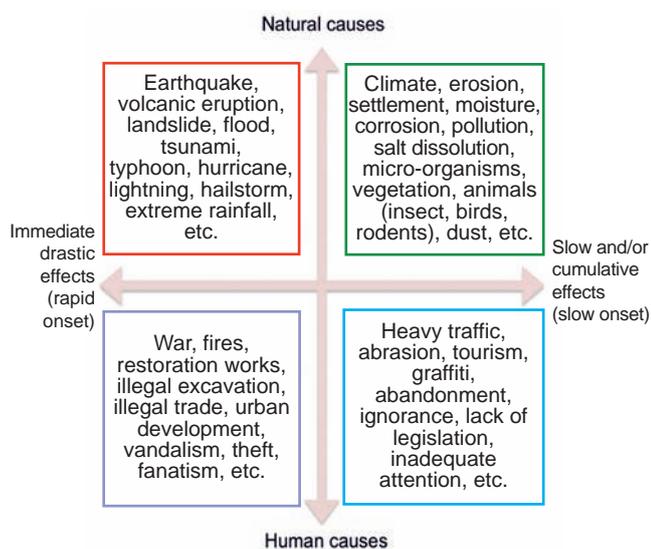
Fig. 1 – Risk factors for Cultural Heritage (ICCROM 2006, modified).
– Fattori di rischio per il patrimonio culturale (ICCROM 2006, modificato).

Among rapid onset natural phenomena the major role of disrupting cultural heritages is played by earthquakes, floods and landslides. It is difficult to estimate the percentage of losses caused by any kind of phenomena but, while earthquakes and floods hit a very large area and a large number of monuments in the same moment, landslides are acting more locally, at the scale of the phenomenon, and a statistic is rather complicate. As an example, it is possible to say that among the Italian UNESCO sites inscribed in the World Heritage List, 25% of them is affected by mass movements,

54% from floods and 82% hit by earthquakes with intensity higher than the damage level. It is also evident that many sites are suffering for multiple hazards. The above reflections, without obviously being exhaustive of the problem list, clearly underline the impact that the Earth Sciences have had in the construction, development and maintenance of the cultural properties; it is evident that the same disciplines have to assume a fundamental role in all the policies that are today necessary for the protection of the heritage. This passage has never been very clear in the past, since the archaeology and the conservation aspects had a strong centrality and autonomy. This point of view is now less evident, with more attention to the integration of different sciences. In reality it is possible to affirm that the protection of the cultural heritage represents an interdisciplinary process (and not multi disciplinary) to the borderline among art, history, science, policies for management and fruition. The following figure 2, from Fitzner B. (2004, modified) it underlines the articulation of the disciplines and the necessary investigations to the resolution of real problems of conservation.

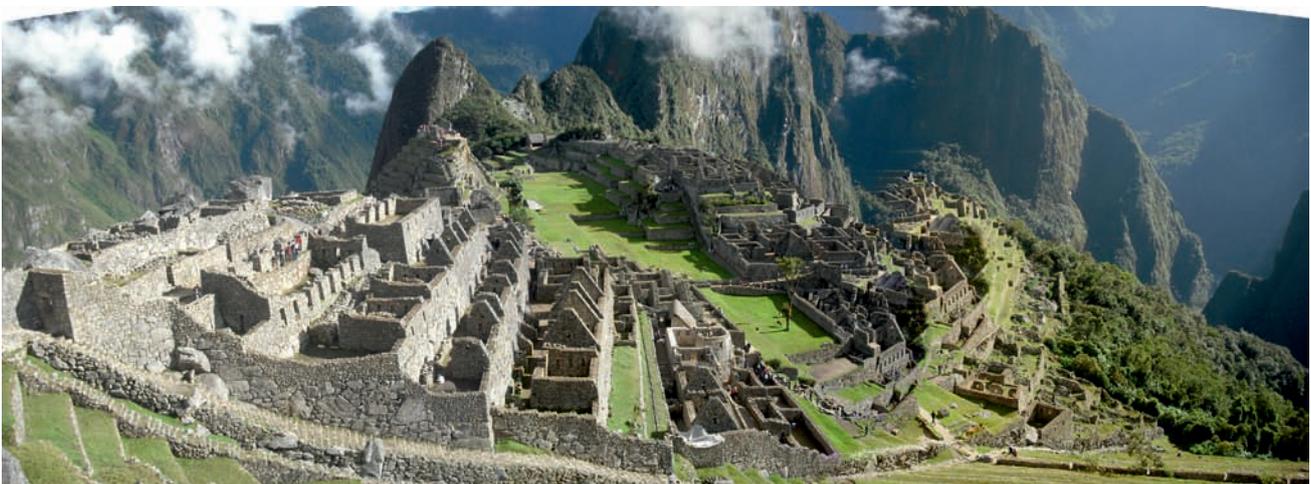
Fig. 4 – View of Machu Picchu site.
– *Vista del sito di Machu Picchu.*

Machu Picchu (fig. 4), is the most noteworthy archaeological site of Peru and is included in the UNESCO World Heritage List. Recent studies, carried out by the DPRI of Kyoto University (SASSA *et alii*, 2001 and 2002), pointed out the presence of large mass movements within the archaeological area. Even if the site was well maintained by the Peruvian Government such new information arrived totally unexpected and caused many problem on the development of a proper management plan. In 2001, the Italian Ministry of Education, University and Research (MIUR) approved a

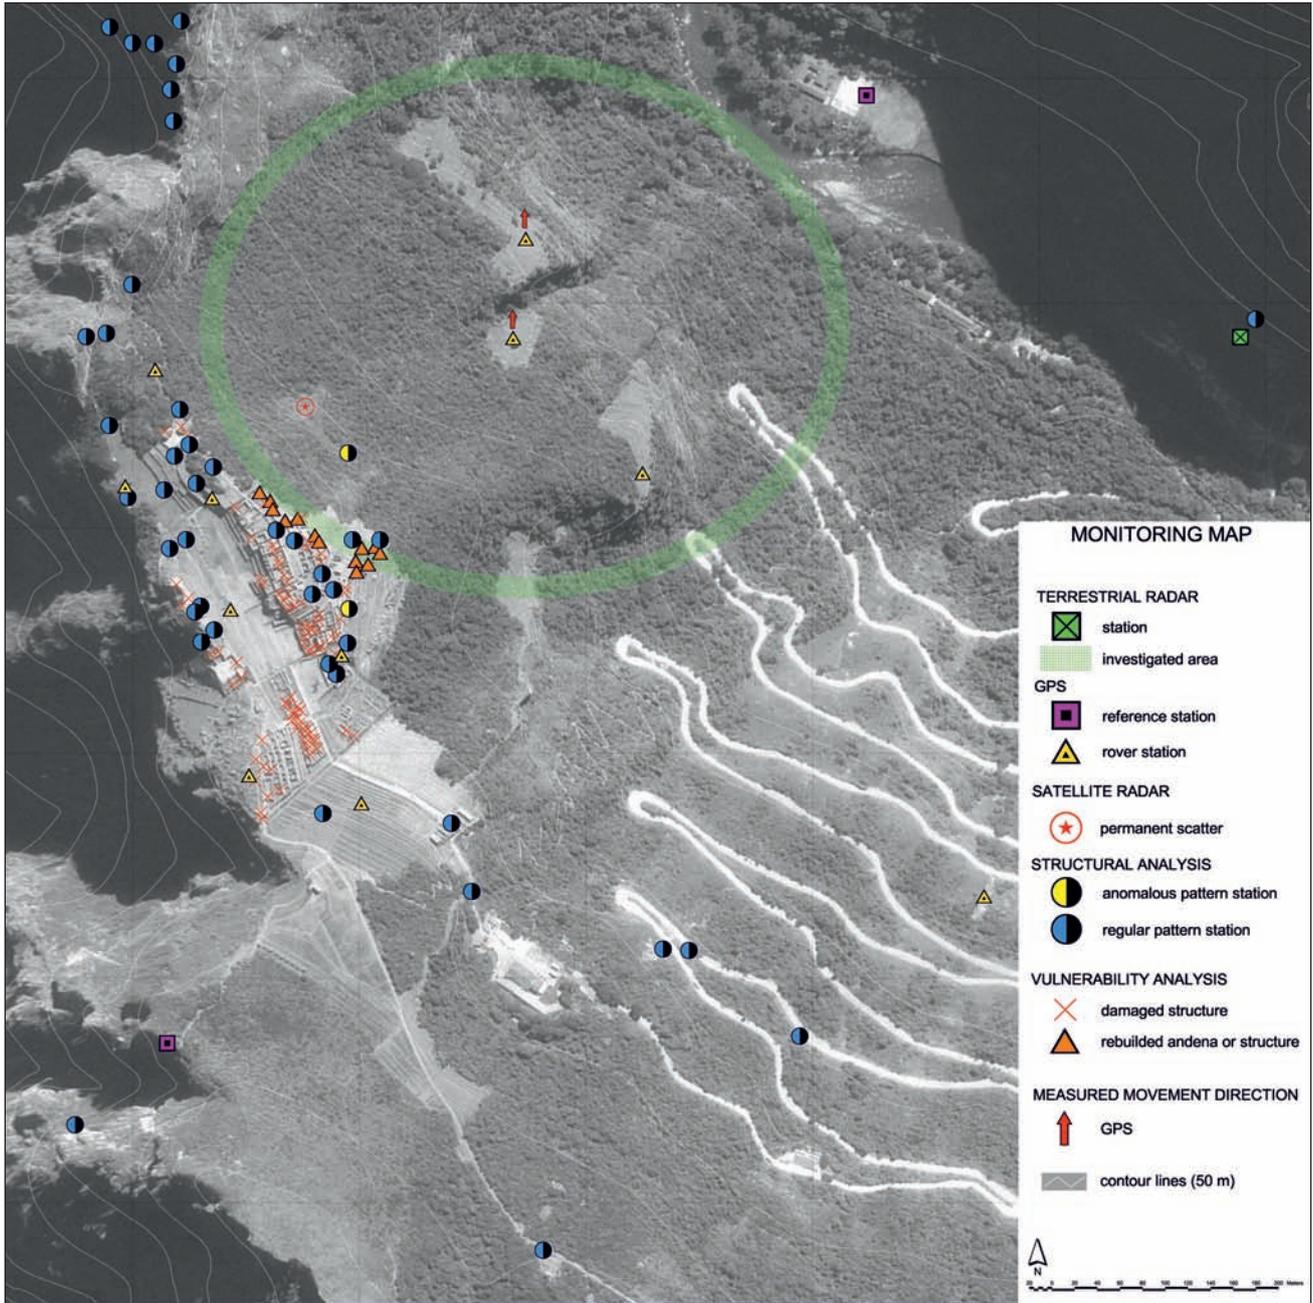
Fig. 5 – Integrated map of surface deformation evidences and present monitoring data.
 – *Mappa integrate delle evidenze delle deformazioni superficiali e del sistema di monitoraggio.*

The analysis of monitoring data, integrated with field observations is suggesting (fig. 5):

1 - the stability of the upper part of the citadel were

several GPS sensor do not exhibit any movements; also archaeological structures seem to be relatively undamaged;

2 - the continues rock falls in the S-W side of the cliff and related citadel's border, were also archaeological structure have been damaged by progressive lateral detensioning; this is probably the area with the highest short-term conservation problem.

3 - the presence of a paleo-landslide in the North-East flank, with likely thickness of some tens meters, limited by a tension crack discovered in 2004; in this area neither GPS nor PS from GBR-SAR detected any kind of deformation; in this area also structural geology detect some not regular pattern in the measurement. Finally, the collected data are beginning to give a first picture of the slope evolution of the site. Nevertheless, the analysis of the monitoring data collected from the systems installed by Italian, Japanese and Czech-Slovak groups, together with data provided by Canadians and Peruvians, will allow a better evaluation of the mechanisms of slope processes and of landslides, leading to a complete harmonization amongst the observation of the different research groups involved.

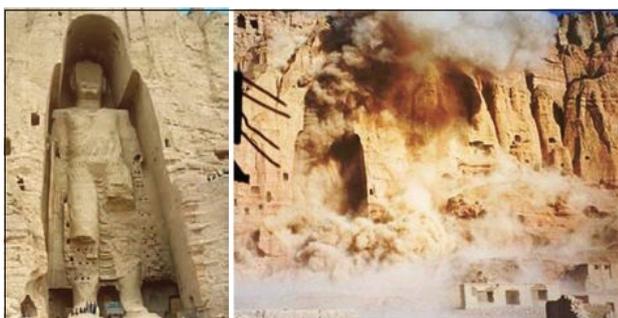
Fig. 7 – The destruction of Western Giant Bamiyan Buddha.
– *La distruzione del grande Buddha di Bamiyan.*

The result of demolition was impressive: the two large statues were destroyed, the niches where the Buddhas were carved were almost to collapse, many mural paintings were finally covered by asphalt. Slope instability due to the explosion as well as natural processes were quite evident: rock slides, and rock falls have already occurred in the past and during the explosion, and most other areas were prone to collapse. Explosion of March 2001, apart the collapse of statues, produced a deterioration of the stability conditions, mainly in the superficial part of the niches.

In the small Buddha niche, besides the collapse of the statue, three minor rock falls occurred in the top. In the mean time, the blasting produced a degradation of the upper part of the niche in the eastern side. In this area a stair-cave is located inside the cliff and the sect between the stairs and the niche is quite thin (about 30-50 cm). This sector was at that time estimated as the most critical for future stability. The western side, as consequence of an existing buttress, did not suffered substantially. A rock fall occurred and some instabilities were evident in the upper part. In the large Buddha the collapse of statue and the consequent instability of the back side of the niche were the major effects. A small rock fall occurred on the top of the niche. Probably, the thickness of sect between the stairs going up into the cliff and the niche (about 1 m), did not allow a large propagation of the effects of blasting and consequently a severe damage. Under the UNESCO coordination, a global feasibility project for the needed restoration work was initially implemented after an extensive engineering geological investigations in very difficult conditions (e.g. landmines). Field data were collected and a mechanism for potential cliff and niches evolution were provided. The present paper describe all the emergency intervention performed in Bamiyan (Central Afghanistan) for the consolidation of niches and unstable blocks (fig. 8) resulting from the explosion, executed by Taliban in March 2001, aimed at destructing the VI c. A.D. giant statues of Buddha. The effect of explosion was quite dramatic: the two statues totally collapsed but also some small part of the niches fall down and, mainly large part of the Eastern Giant Buddha Niche was close to the collapse. UNESCO was immediately prompt to undertake an emergency intervention for securing the remaining of such wonderful cultural heritages and, thanking to the generous Government of Japan financial support, the works started in November 2003.

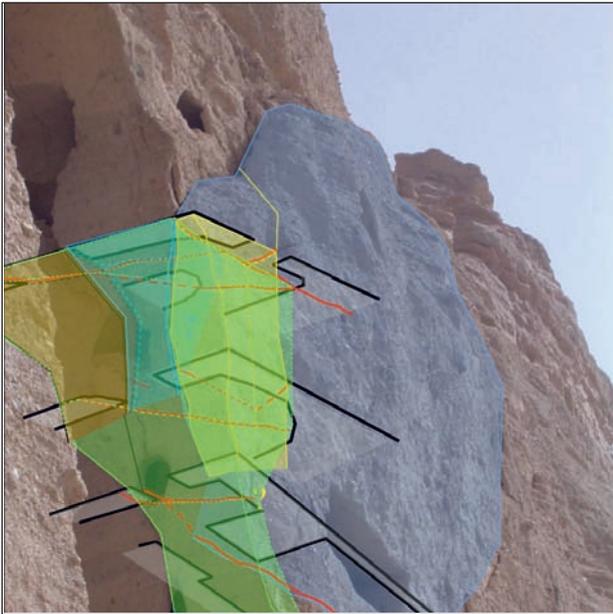
Fig. 8 – Pattern of existing discontinuities at four different stories and reconstructed unstable blocks in the upper East side of Eastern Giant Buddha niche.
– *Pattern delle discontinuità presenti su quattro diversi livelli e ricostruzione dei blocchi instabili nella sommità della parte orientale della nicchia del Grande Buddha.*

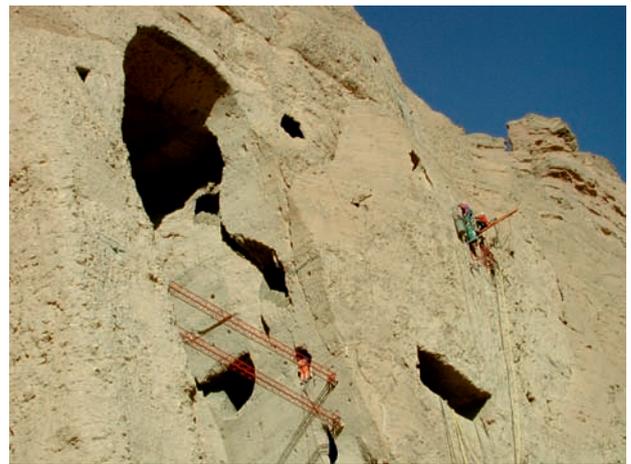
Fig. 9 – Consolidation works on the Bamiyan niche.
– *Lavori di consolidamento nelle nicchie di Bamiyan.*

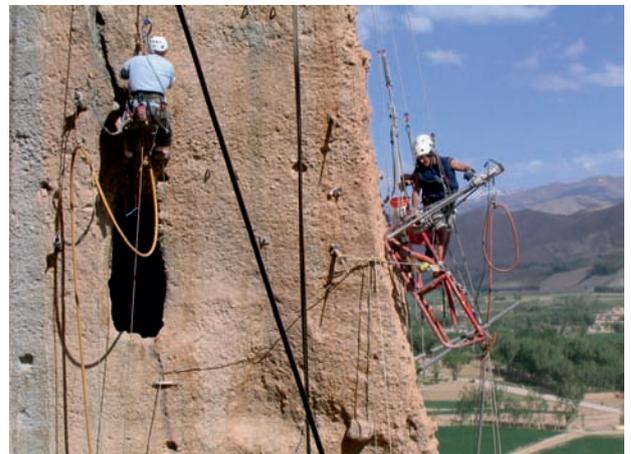
Fig. 10 – Consolidation works in the Bamiyan cliff.
– *Lavori di consolidamento sulla parete di Bamiyan.*

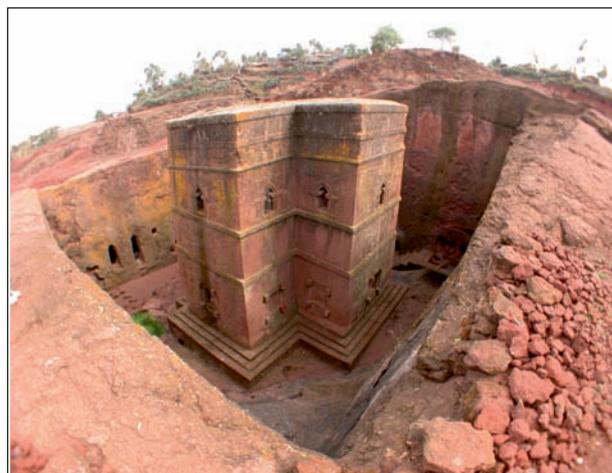
Fig. 11 – The church of Biet Gyorgis in Lalibela.
– La chiesa di Biet Gyorgis a Lalibela.

Lalibela is located in the northern-central part of Ethiopia, approx. 600 km north of Addis Ababa in Northern Wollo, one of the most structural food deficit areas of the Amhara Region. The town, which has about 12000 inhabitants, is situated at an altitude of 2500 m. In its centre a unique complex of 11 rock-hewn Christian Orthodox churches is located, cut out of the living rock some 800 years ago whose construction is attributed to King Lalibela (1167–1207). All churches are widely affected by structural damage and weathering (DELMONACO *et alii*, 2010) that are posing a serious problem for the future preservation of these monuments. Geological field surveys, in-situ geotechnical analyses and recognition of various weathering processes have been preliminary carried out in the area providing a classification of the churches according to structural damage. Laboratory tests on volcanic materials have detected a deep alteration of rocks due to chemical and physical weathering as well as the diffuse presence of montmorillonite. This may be recognised as the main cause of the progressive deterioration of the physical and mechanical characteristics of the slope-forming rocks in Lalibela. Following the new scientific findings on the weathering processes affecting the Lalibela Churches it will be possible to detect and implement urgent and medium/long-term protection strategies for the conservation of the monuments (fig. 11).

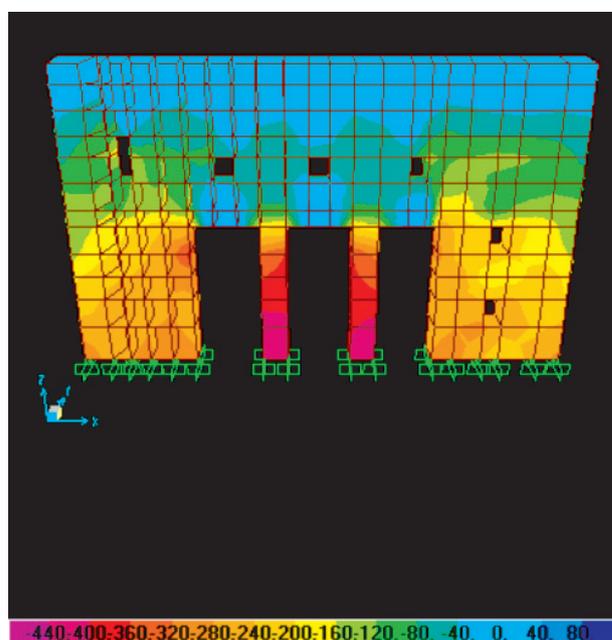
Fig. 12 – Structural analysis of the Biet Amanuel Church showing a load, in the central pillars, of about 4,5 KPa despite of a UCS of 50 KPa.
– Analisi strutturale della chiesa di Biet Amanuel che evidenzia un carico nei pilastri centrali di circa 4,5 KPa rispetto a un UCS di 50 KPa.

Looking more in detail the damage on the different Churches it has to be mentioned the situation of Biet Ammanuel where the heavy static load and the reduction of strength due to weathering is producing an important discontinuity pattern that is posing serious problem on the future stability. Likely, the load of the roof on walls is evaluated in about 10 % of the Uniaxial Compressive Strength (UCS) giving further possibilities for a future appropriate static study and a proper consolidation design (fig. 12).

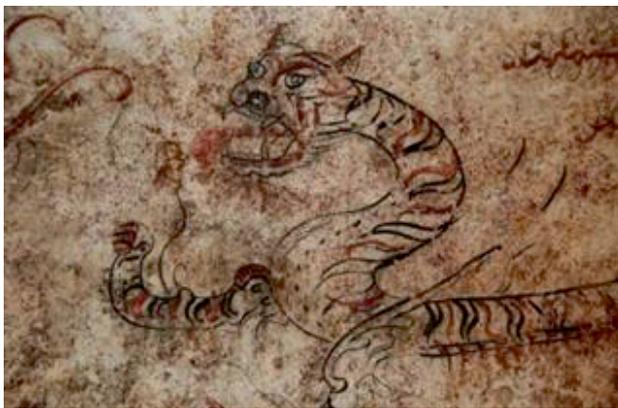
Fig. 13 – Painting in the Yaksuri mural tomb.
– *Pittura murale nel sepolcro Yaksuri.*

The tombs, and the related mural paintings (fig. 13) are now suffering for various problems like (MARGOTTINI, 2005):

- 1 - Humidity
- 2 - Water infiltration (from precipitation and underground water)
- 3 - Structural instability

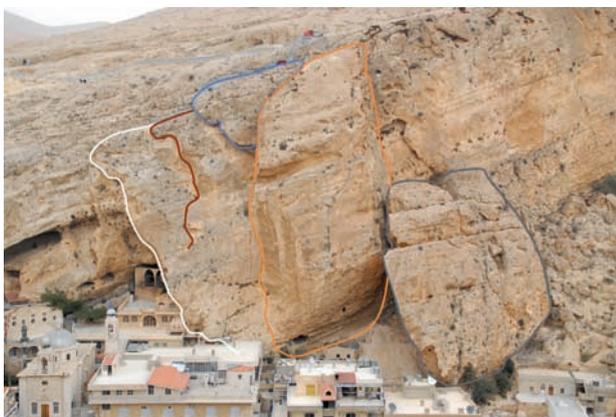
Fig. 14 – The Monastery of Saint Tekla, on the left, and the hanging cliff.
– Il Monastero di Santa Tekla, sulla sinistra, e la parete aggettante instabile.

3 - a gigantic rock mass is hanging over the town of Maaolula and partially, over the Santa Tekla Monastery. This mass is kinematically prone to slide but, according to preliminary evaluation, in condition of equilibrium. Nevertheless, the preliminary stability analysis may lead to a potential instability, in seismic condition and very conservative water content and geotechnical parameters. Monitoring data with total station in 2007 confirm these assumption and no evidences of recent displacements have been detected;

According to the above statement it was decided to implement a new project, taking into account the most advanced knowledge in rock mechanics, and to limit present day intervention. These could be constrained to very small block for which an emergency intervention is highly required. In fact, considering the height of the cliff, even a small rock fall can be devastating for the below Monastery (figs. 14, 15).

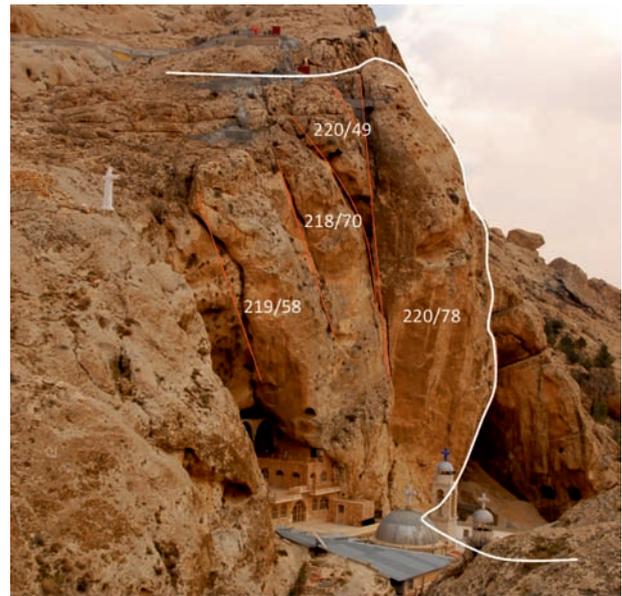
Fig. 15 – The monastery of Santa Tekla and the cliff and discontinuities.
Data are reporting dip direction and dipping
– Il monastero di Santa Tekla e le discontinuità presenti in parete. I dati riportano direzione e pendenza.

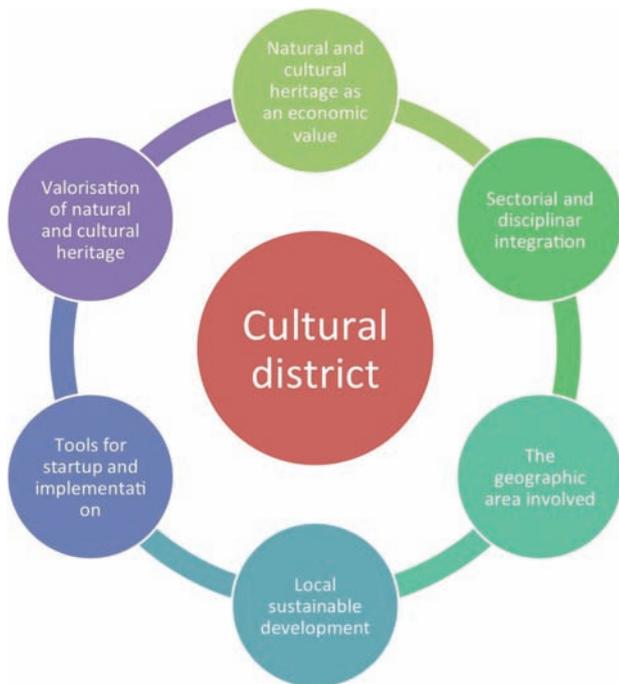
Fig. 17 – Strategies for a local economic development based on natural and cultural heritages (VALENTINO, 1999).

– *Strategie per uno sviluppo economico locale basato su patrimoni naturali e culturali* (VALENTINO, 1999).

valorisation of their history, tradition and in other world tangible and intangible heritages. The implementation of the above described process is also connected with the integration of many territorial tools and available expertise and knowledge, within a given geographical context. Such strategy, applied in a given area or “cultural district” may be represented in figure 17.

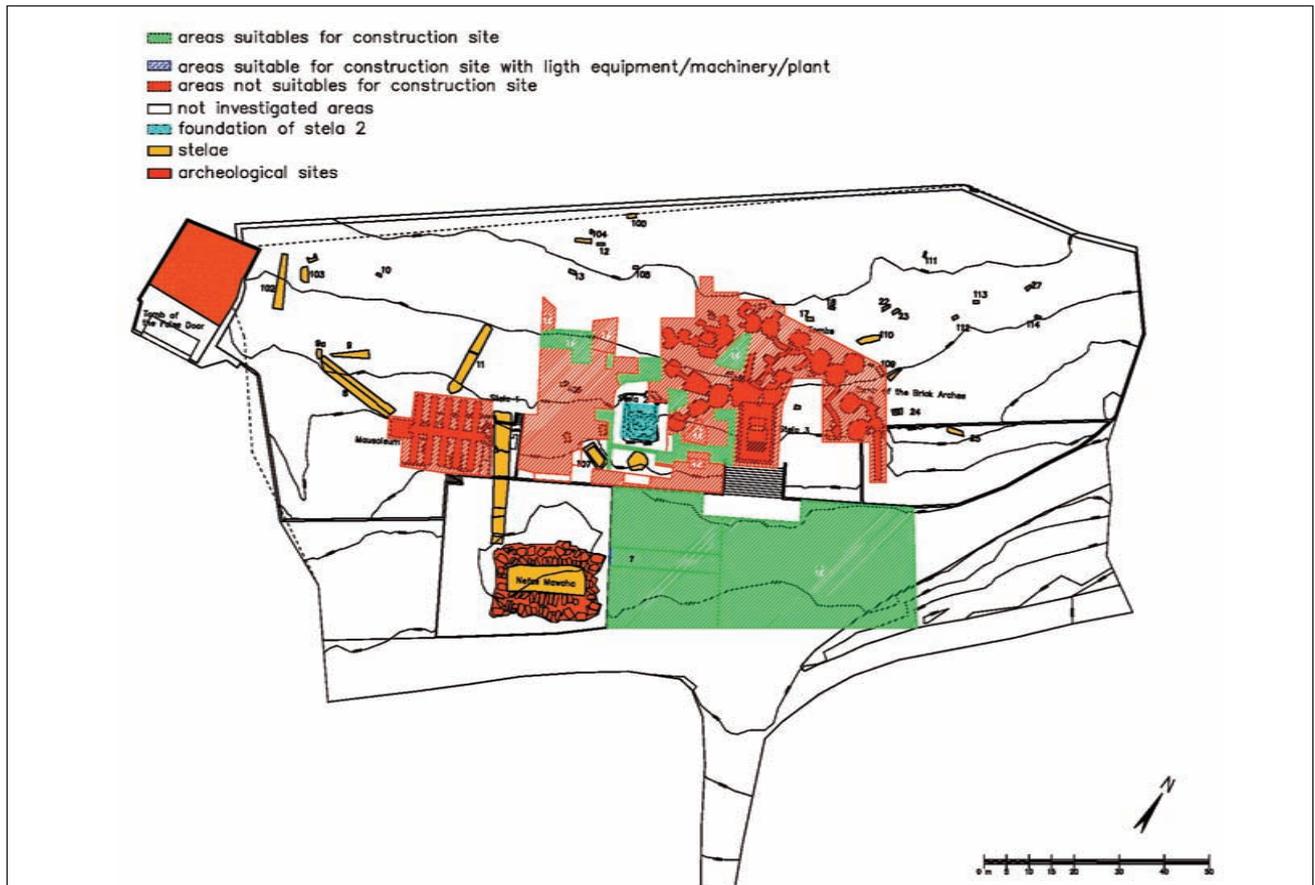
Fig. 21 – The zoning of Aksum Stelae park for the implementation of the re-erection of the stela n.2, returned from the Government of Italy to Ethiopia.
 – La suddivisione in zone del parco delle steli di Axum per la cantierabilità e la ri-erezione della stela n.2, restituita dal Governo Italiano all’Etiopia.

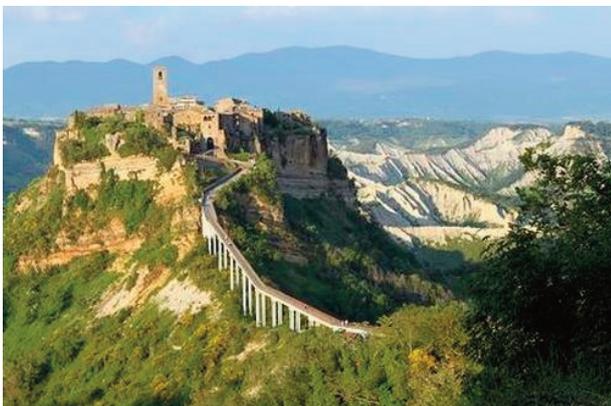
Fig. 22 – Civita di Bagnoregio with, in the background, the bad lands geo-heritage area.

– Civita di Bagnoregio con il geosito della valle dei calanchi sullo sfondo.

Civita di Bagnoregio (fig. 22) is a small village in Central Italy, located in the top of a volcanic hill and affected by continuous landslides that are progressively reducing the urban area. This is the main feature of a geo-heritage potential park with spectacular phenomena of bad land and clay erosion (DELMONACO *et alii*, 2009).

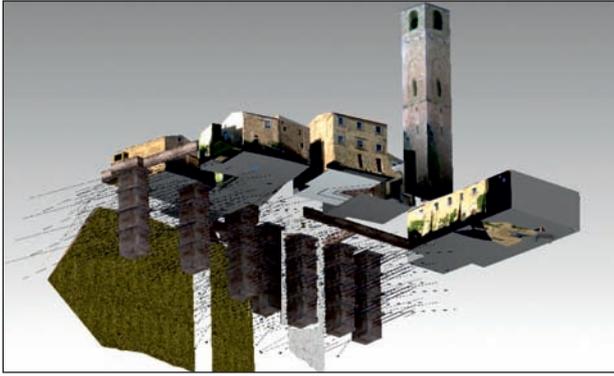
Fig. 23 – The innovative consolidation work for the stabilization of rock slope in Civita di Bagnoregio: Anchors and bolt realized from structural wells.
– *Una innovativa tecnica di consolidamento per la stabilizzazione della rupe di Civita di Bagnoregio: chiodi e ancoraggi realizzati da pozzi strutturali.*

- 1 - Securing the town of Civita di Bagnoregio from rock fall and rock slide;
- 2 - Increasing of tourism capacity of the area;
- 3 - Sustainable mobility to access to Civita (presently a not pleasant bridge is on the spot) and within the bad lands area;
- 4 - Valorisation of the bad land geo-heritage park;
- 5 - Establishing a permanent centre for the study, monitoring, consolidation and maintenance of unstable towns and mitigation of hydrogeological disasters (fig. 23).

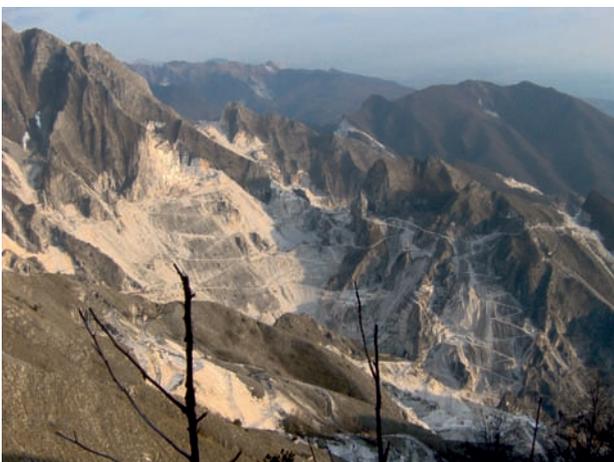
Fig. 24 – The unique landscape of Carrara marble area (wikipedia.org).
– *Il paesaggio unico delle cave di marmo a Carrara (wikipedia.org).*

Geo-heritage site are sometimes also the result of interaction between man and environment. This is the case of the Carrara marble caves (fig. 24), (Northern Italy) where the excavation of the very famous marble, produced a unique landscapes, well known in the last 2.000 years. Nevertheless, many quarries are often abandoned after the complete excavation and they pose serious problem for future landscape. Sometime such a quarries become also a place where to put waste and garbage, disqualify the whole environment. There is case in which the application of the principle of inter-connecting in a unique virtual network different “knowledge” such as the empowerment, has provided an exceptional outcome.
