*MJV for Seveso Inspections on
RISK MANAGEMENT AND ENFORCEMENT FOR AGEING SITES
10-12 April, 2019, Malta*

Ageing of hazardous installations in Italian Seveso establishments: accidents, results of inspections and good practices

ISPRA - Italian National Institute for Environmental Protection and Research

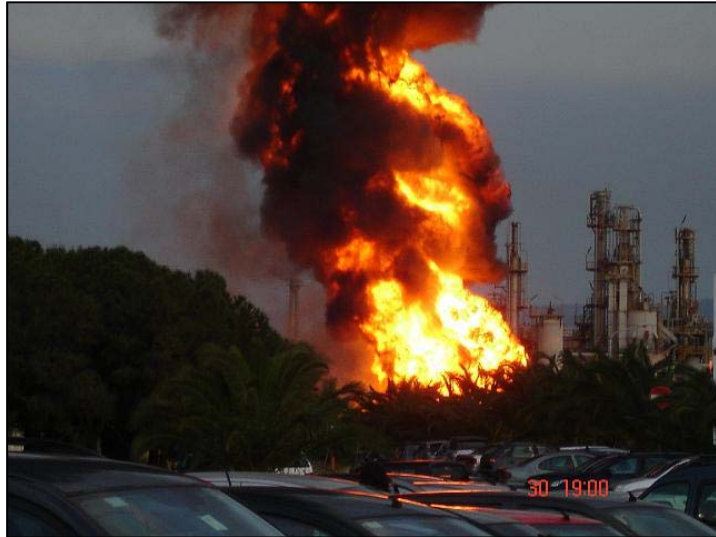
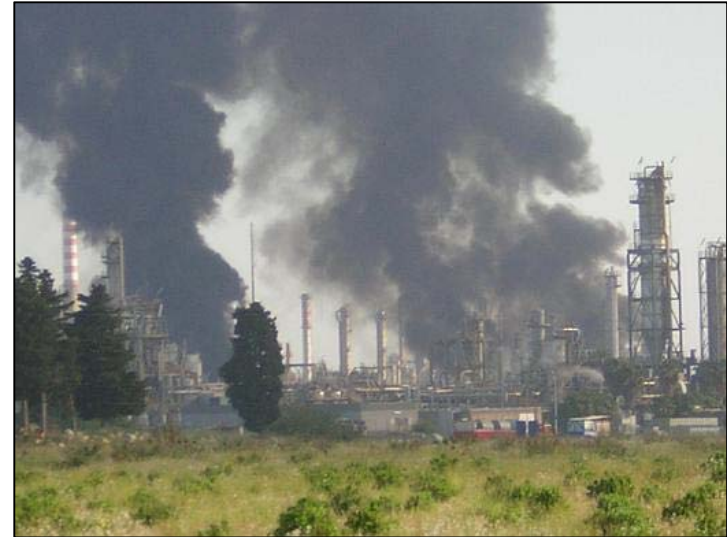
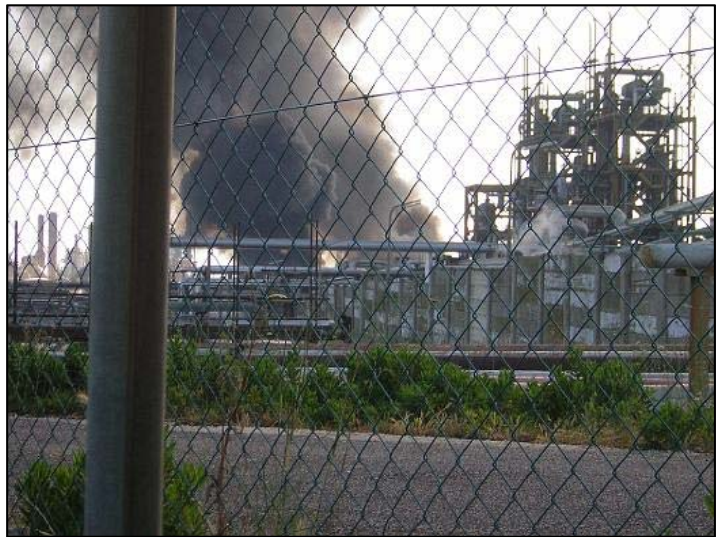
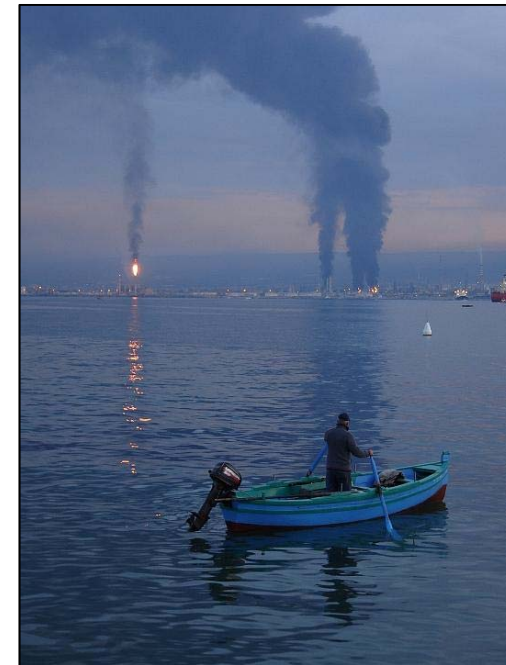
Fires and explosion at the refinery plant

Date: 30/04/2006		Title: Fire and explosions in piping	
Synthetic description: Release of crude oil from transfer pipe in the underpass of the road that crosses the plant, that developed a fire by accidental triggering which subsequently involved the adjacent piping and then a series of explosions			
Causes: Age (over 25 years) and state of preservation of the pipe in relation to the progressive corrosion phenomena, which led to the pipe drilling			
Organizational factor / Description		Actions taken	Expected / Planned actions
Emergency planning - Consequences analysis, planning and documentation		Internal emergency plan activation with major risks emergency forwarding. Intervention of refinery and neighboring establishments fire departments and local Fire Brigade	Internal emergency plan check
Identification and evaluation of major hazards – Planning for plant and management compliances to risk reduction and updating		Investigation to find out the causes of the accident. Visual inspection and basic design of corrective actions. Necessary reconstruction activities	Specific risk analysis. Planned and/or required compliances following CA examination. Check of the pipeline inspection plan

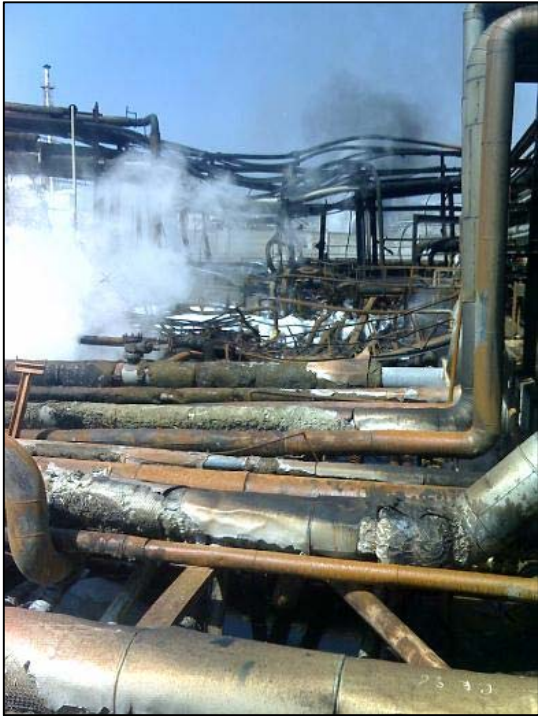
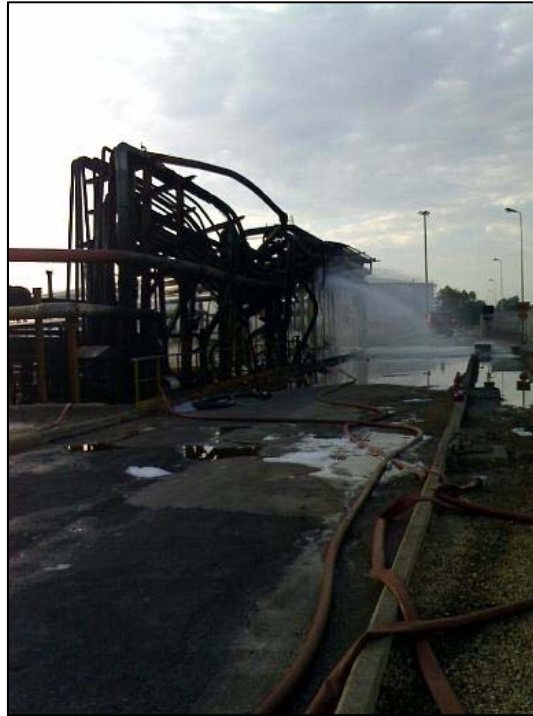
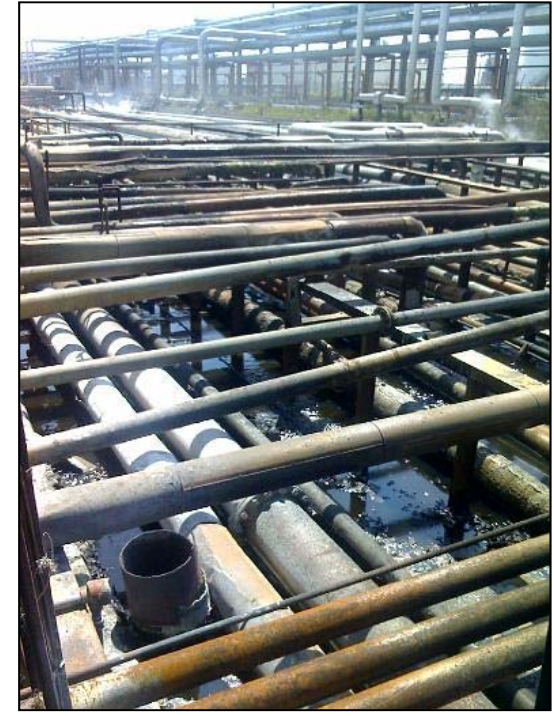
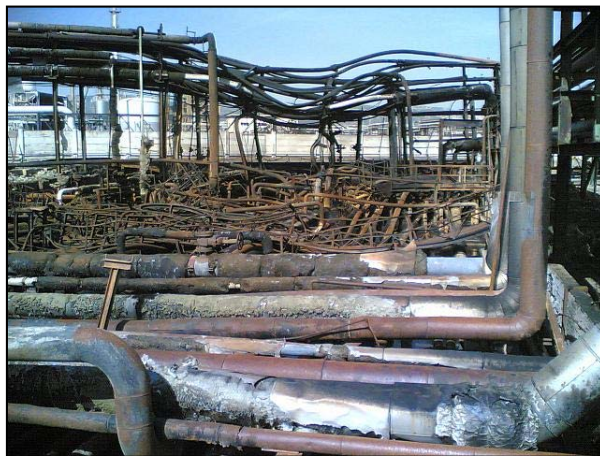
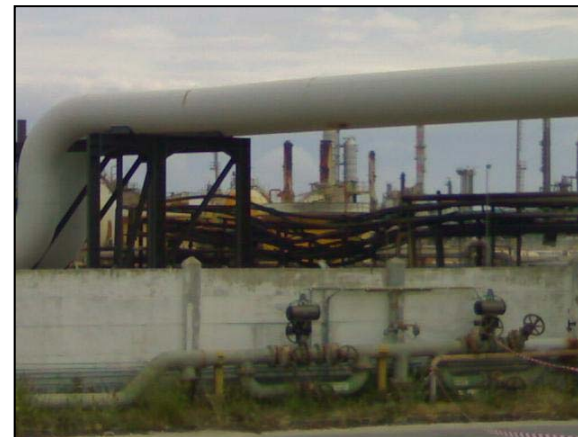
The pipeline rack after the event

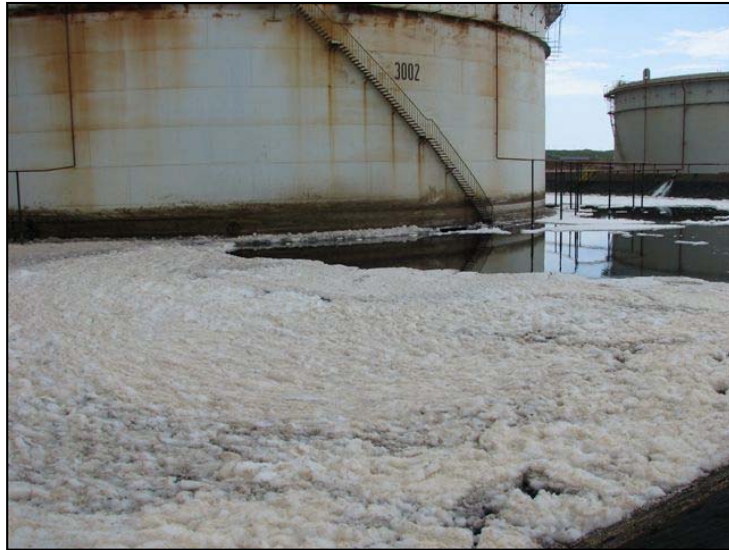
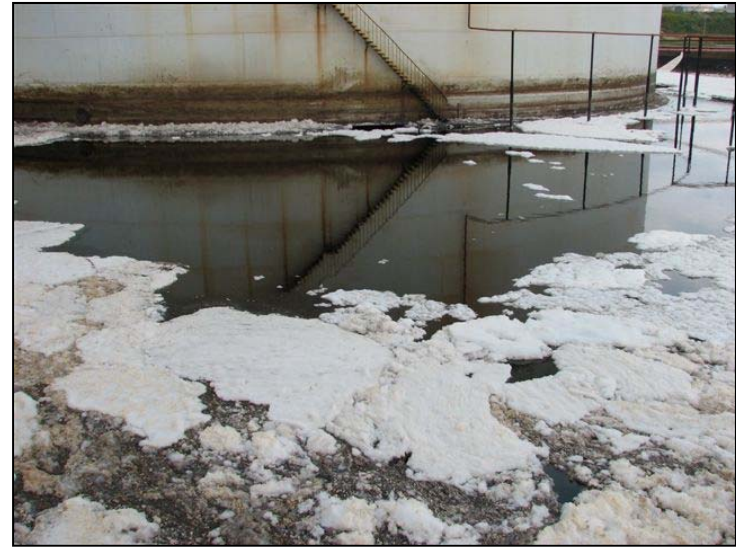
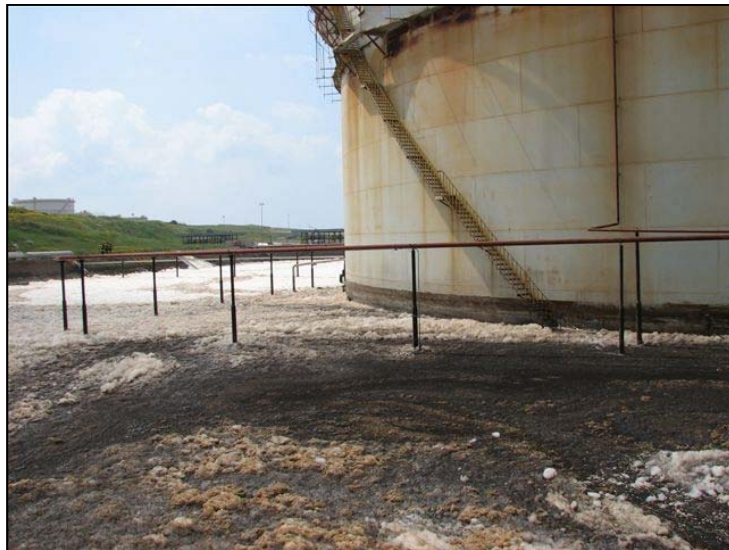
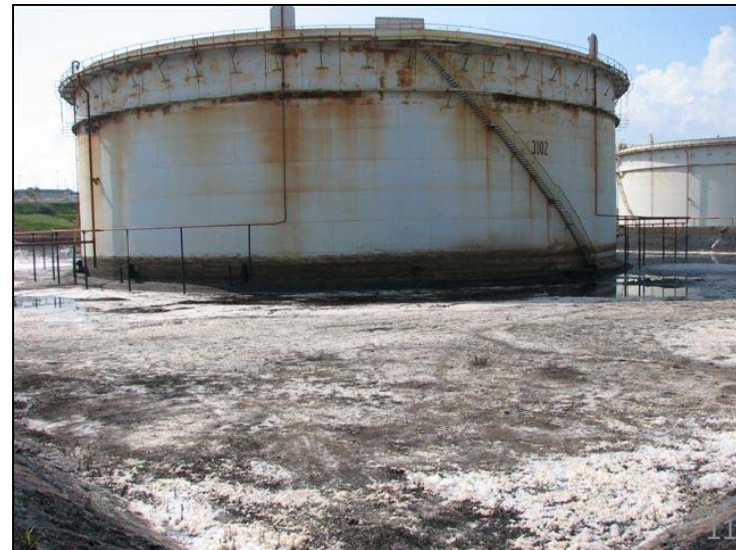
Date: 01/05/2006		Title: Leakage through the tank bottom	
Synthetic description: Leakage of oil through a large lesion at the bottom of a floating roof tank and subsequent release of a significant amount of oil inside the containment basin			
Causes: High corrosion and deteriorated area			
Organizational factor	Description	Actions taken	Expected / Planned actions
Operational control - Identification of installations and equipment subject to maintenance plans	Release of oil inside the containment basin	Tank insulation. Covering the spilled oil with foam to limit the vapor emission. Transferring the product to another tank with temporary pipes	Tank out of service. Carrying out the remediation and maintenance of the basin and the tank. Double bottom insertion

The containment basin after the event: the rupture area

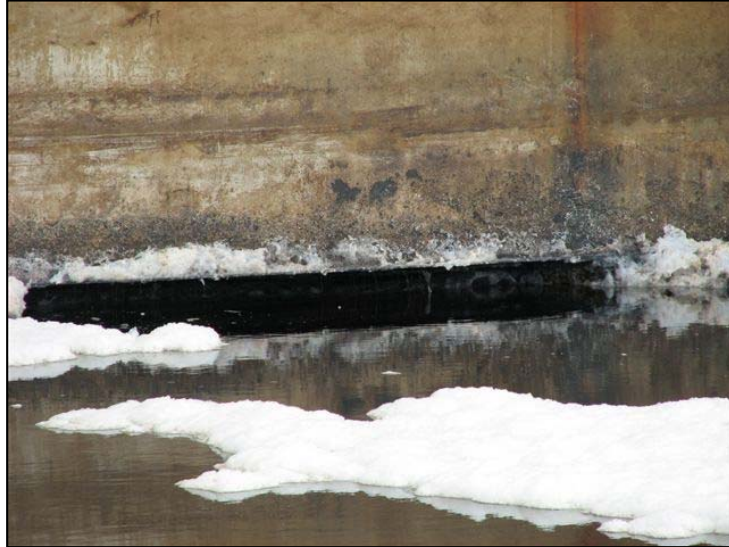
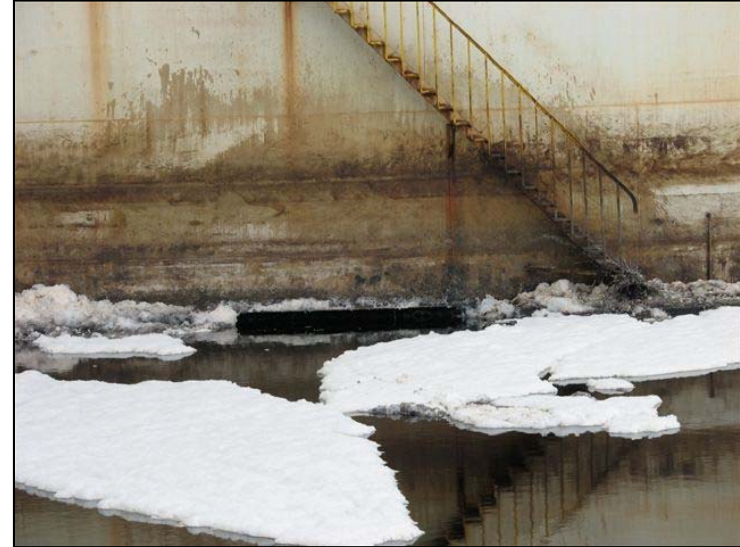
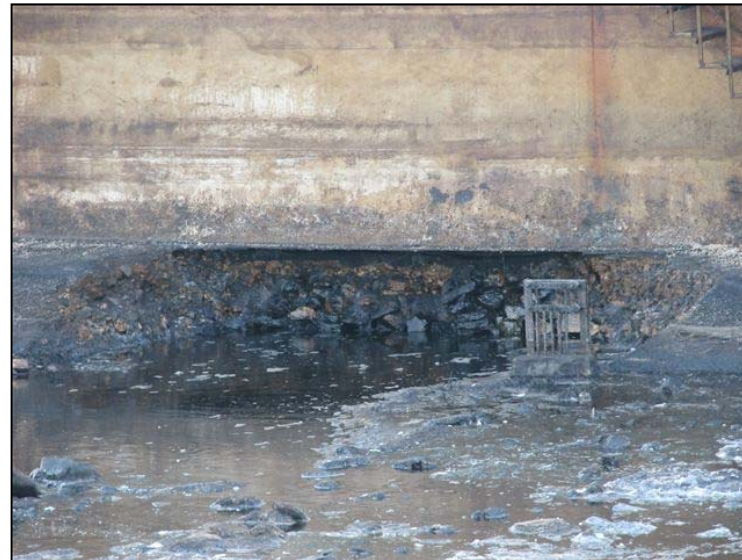
The lesion at the tank bottom

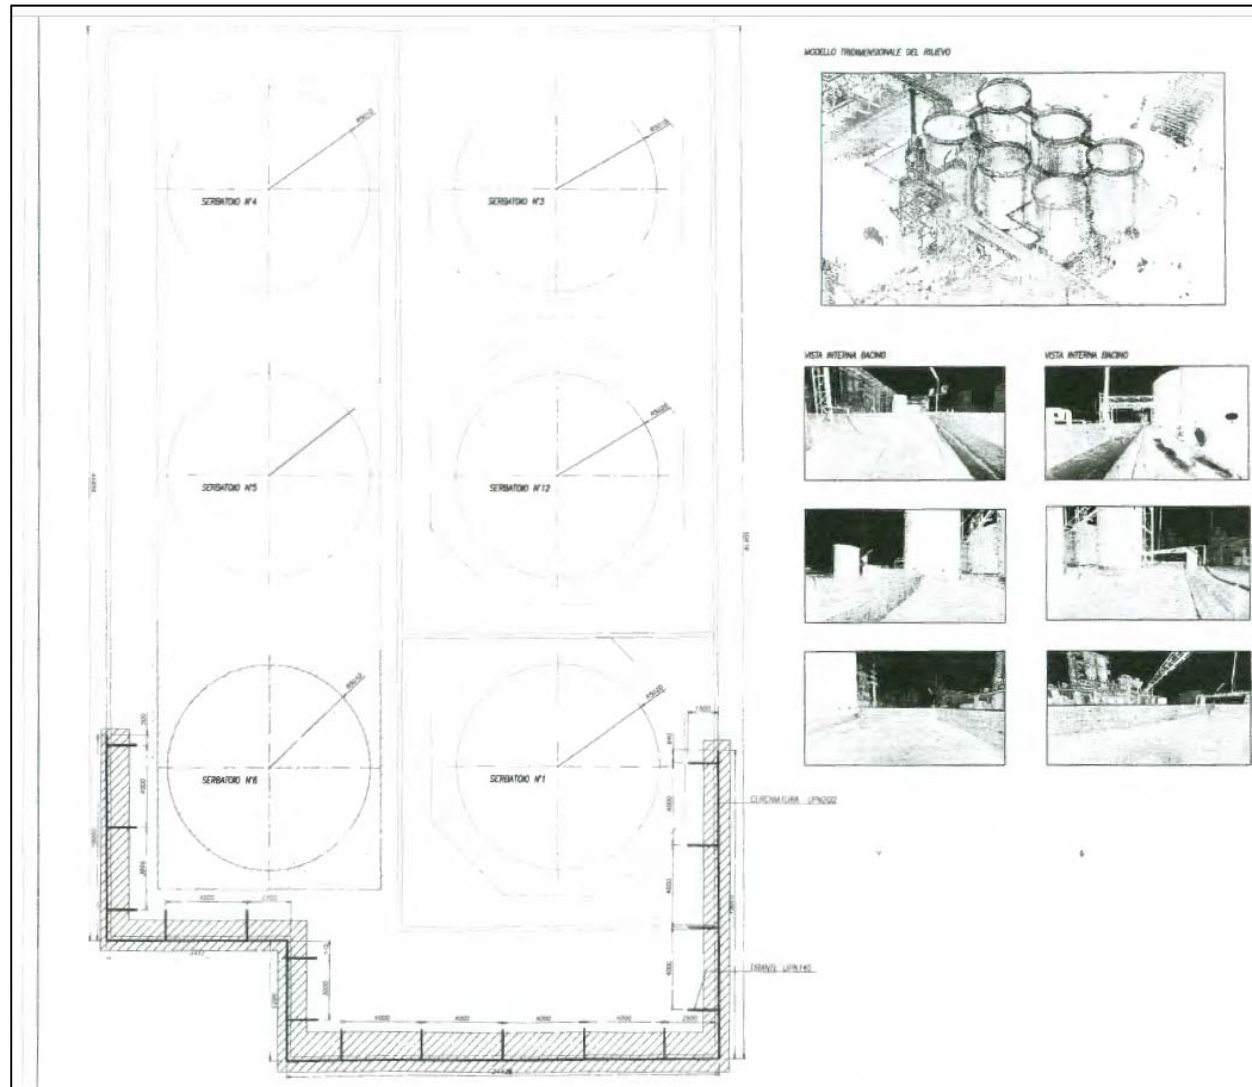
Tank park and containment basin

Date: 25/05/2017	Title: Spill of sulphuric acid from a supply pipe in an underground channel		
Synthetic description: As a result of the accidental damage of a sulfuric acid (H2SO4) pipe, connecting the storage tanks (6 tanks above ground) with the buried tank in front of it, a spill occurred in the buried channel housing the pipeline itself. This spill of H2SO4 in the subsoil caused the structural failure of one tank and the relative rotation of the base of the containment basin.			
Causes: Spill of H2SO4 in the subsoil, following a leak from a connecting pipeline, caused by advanced corrosion in a section of this pipeline not accessible to the controls . It has been supposed a duration of the spill in the subsoil of about 40 days, for a total of H2SO4 spilled from the pipe equal to about 45 t .			
Organizational factor	Description	Actions taken	Expected / Planned actions
Identification and evaluation of major hazards – Planning for plant and management compliances to risk reduction and updating	Investigation to find out the causes of the accident. Visual inspection and basic design of corrective actions. Necessary reconstruction activities	Initial report to the Authorities (24 h) and, subsequently, a technical report with: Causes; Actions taken; Effects/Consequences; Spread of pollutants; Measures to be implemented	H2SO4 control system “in and out” of the 4 tanks and the underground tank, with alarm system to CR. Waterproofing of the underground channel. New tank park , in which the content of H2SO4 is transferred from the 4 tanks left in operation

Operational control - Identification of installations and equipment subject to maintenance plans		Monitoring and verification of the deformation of structures . The perimeter wall of the containment basin has been reinforced , in order to ensure the seal of the basin itself	Scheduled maintenance on H2SO4 tanks and monitoring of corrosion of these tanks and of the loading pipes , for the calculation of the corrosion rate in the short and long term and of the residual life (new procedure)
Emergency planning - Consequences analysis, planning and documentation	Emergency procedure concerning the transfer of the product between tanks	H2SO4 tank immediately emptied of the product. Supply lines promptly intercepted and further tank subsequently isolated	Review of the IEP for the management of fluid spills and modification of the format for communications to the Authorities concerned (IED-IPPC, Seveso, etc.)

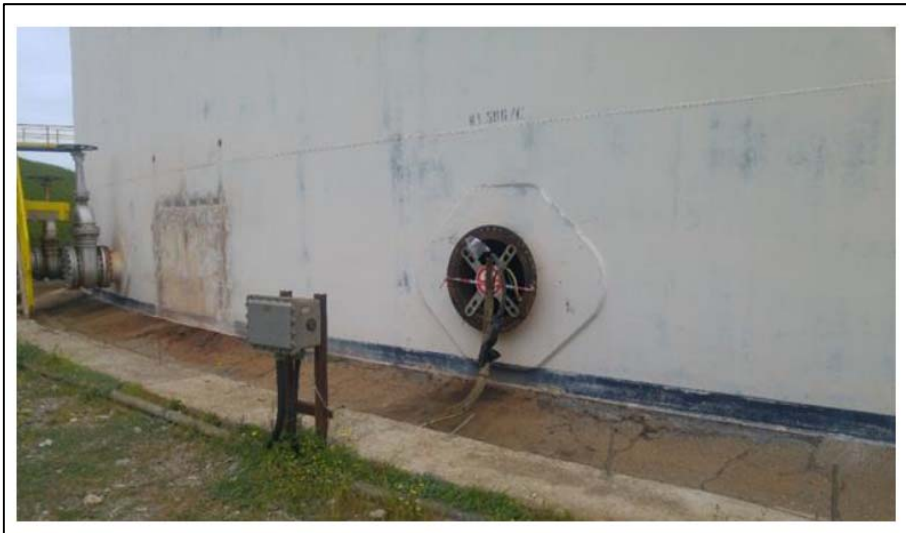
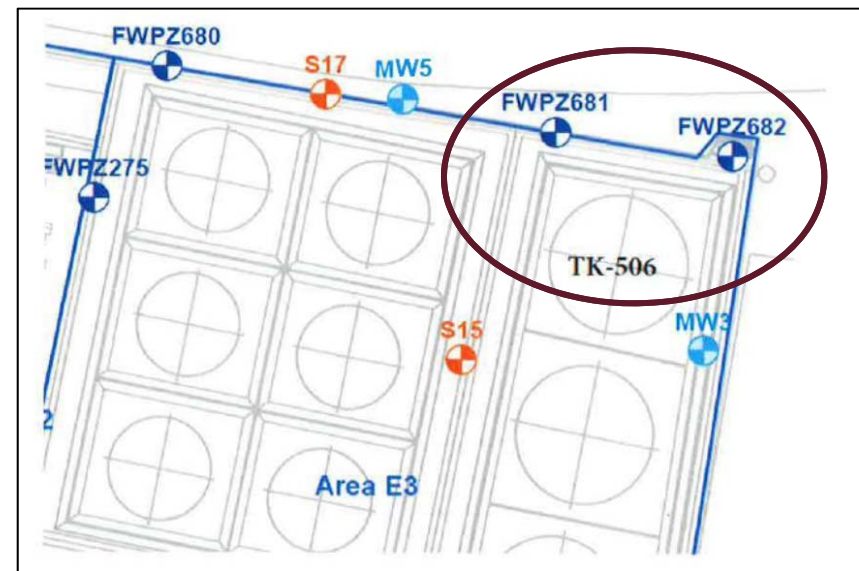
Date: 07/03/2018	Title: Presence of diesel in piezometers near a storage tank		
Synthetic description: Following the sampling at 2 piezometers , located near a storage tank containing diesel , the presence of a supernatant hydrocarbon product of the same type in the tank was found.			
Causes: Spill of diesel in the subsoil, following a leak from a storage tank, caused probably by corrosion in the single bottom of the tank , although this had been subject to maintenance work on the bottom in the previous 2 years (application and welding of overlapping sheets on the existing bottom)			
Organizational factor	Description	Actions taken	Expected / Planned actions
Identification and evaluation of major hazards – Planning for plant and management compliances to risk reduction and updating	Investigation to find out the causes of the accident	Technical report with: Causes ; Actions taken; Effects/Consequences on the environment; Spread of pollutants ; Measures to be implemented	Review of the procedure for the risk analysis on substance spills with environmental hazards (products involved, containment systems, distances from environmental receptors)

The diesel tank and the 2 piezometers

Operational control - Identification of installations and equipment subject to maintenance plans		Construction of a draining trench north of the tank and commissioning of new piezometers . Update of the operational protocol for the hydro-chemical and piezo-metric monitoring of groundwater .	Implementation of the double bottom on all tanks of hydrocarbon products , with viscosity lower than 12 ° E at 50 ° C, with a single bottom. Review of the aging management program of the tanks (Method for the evaluation of the adequacy of the asset integrity management)
Emergency planning - Consequences analysis, planning and documentation	Emergency procedure concerning the transfer of the product	Diesel tank emptied of the product	Review of the IEP for the management of substance spills with environmental hazards
